# SEWER SYSTEM INFILTRATION AND INFLOW ANALYSIS

Town of Bourne, MA

August 2021

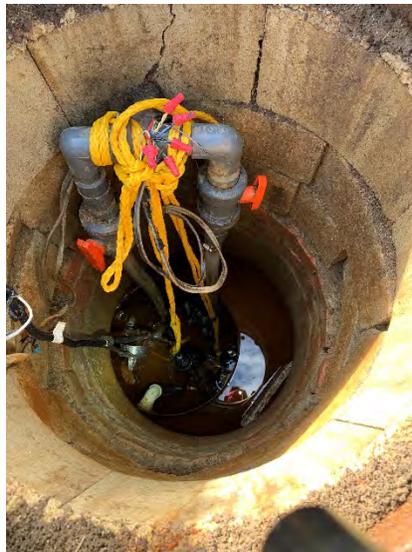
**Figure 2-4: Suspected Tidal Inflow MH**

The Town is coastal and the subsurface conditions are subject to tidal influence. During high tide, the groundwater fluctuates (seasonally) and recedes during low tide. Traditional low-pressure systems are designed to transport only sewage, however the Taylor's Point neighborhood contains a boat pump out station, whose effluent discharges into the low pressure system. During high tides, water has been observed entering the intermediate pumping station, indicating that the collection line requires additional dye and smoke testing. Details on the additional investigation is required is summarized in Section 6.2 Recommendations.
