## PROJECT MINUTES

Project:	New Bourne Intermediate School	Project No.:	15041
Prepared by:	Joel Seeley	Meeting Date:	12/19/19
Re:	School Building Committee Meeting	Meeting No:	77
Location:	Veterans Memorial Community Center	Time:	6:30pm
Distribution:	School Building Committee Members, Attendees (MF)

Re: December 13, 2019  
Evaluation of Water Leakage  
James F. Peebles Elementary School  
70 Trowbridge Road  
Bourne, Massachusetts

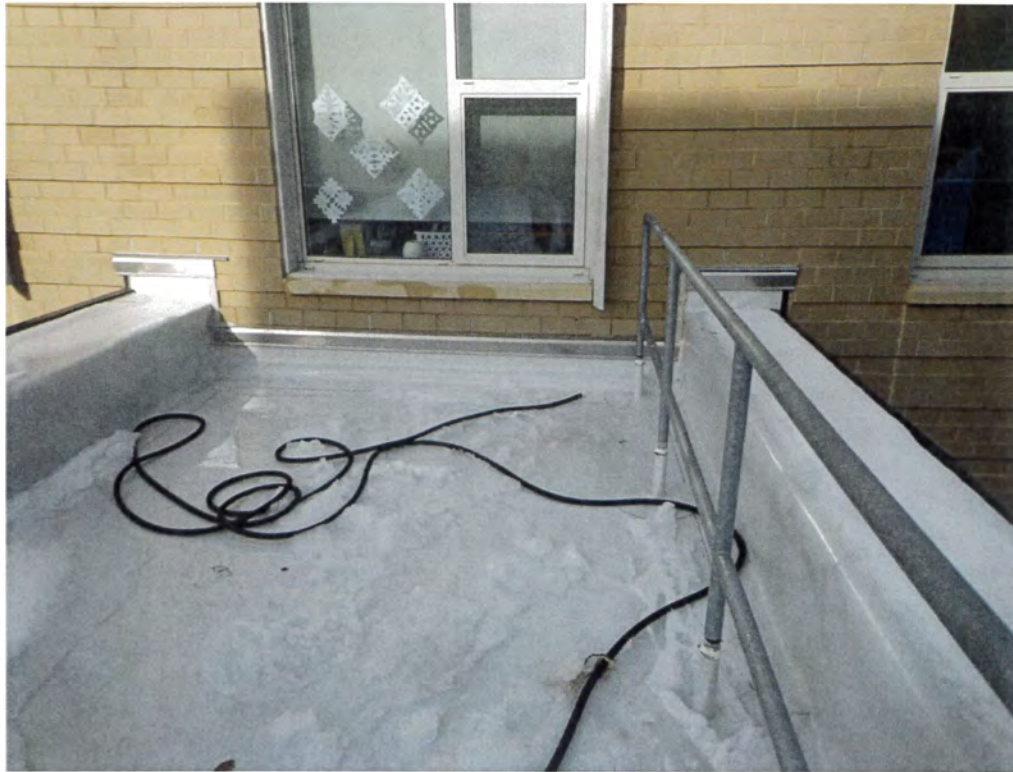
**Photograph 1**  
Water Test 1 at Corridor Expansion Joint

*Test 1 Water was applied for 40 minutes from a  $\frac{5}{8}$  inch diameter hose to the Sarnafil roofing membrane. No leakage was observed on the interior. See Photograph 1.*

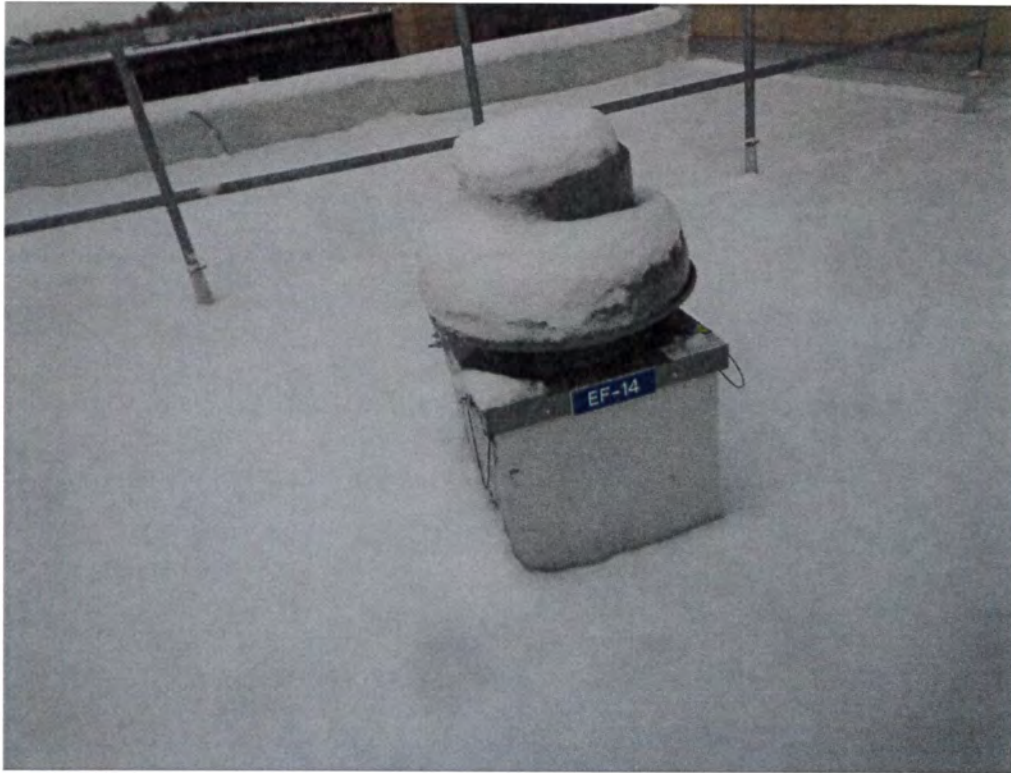
**Photograph 3**

Vent at curb above Studio (Room 124) where gaskets have been installed

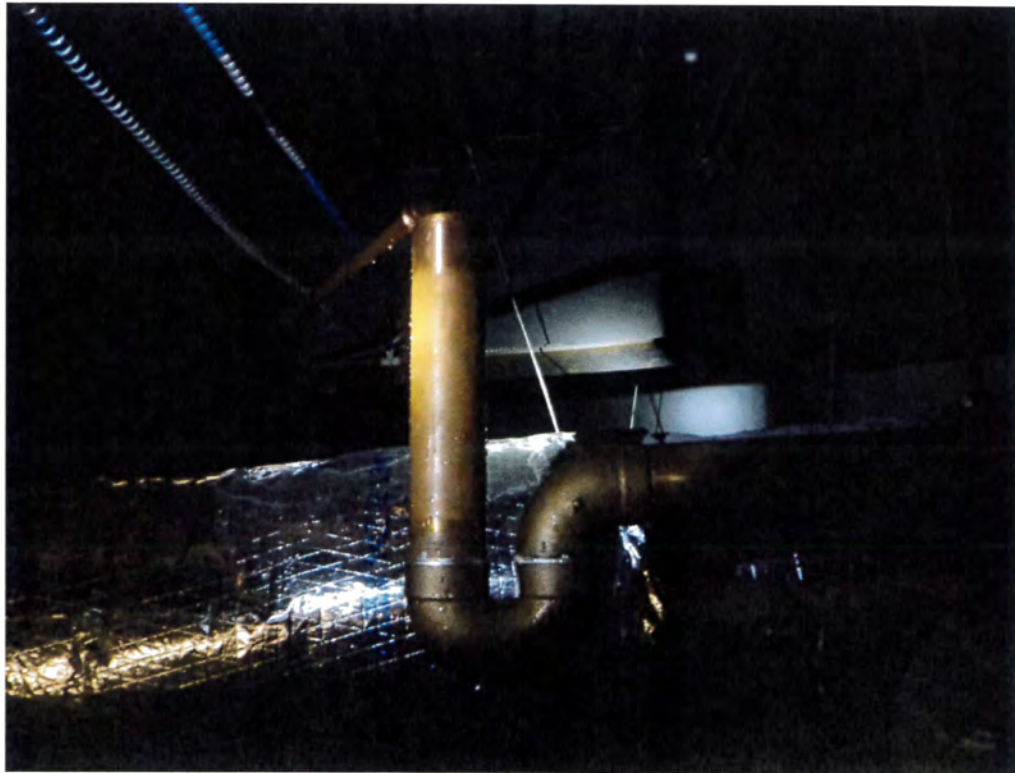
**Photograph 4**

1. *Water stains were observed on the ceiling tiles.*
2. *Water was observed dripping from the ceiling at around 10:00 AM.*
3. *Removal of the ceiling tile revealed that the backflow drain for the roof's water spigot was blocked.*

Backflow drain at Room 211

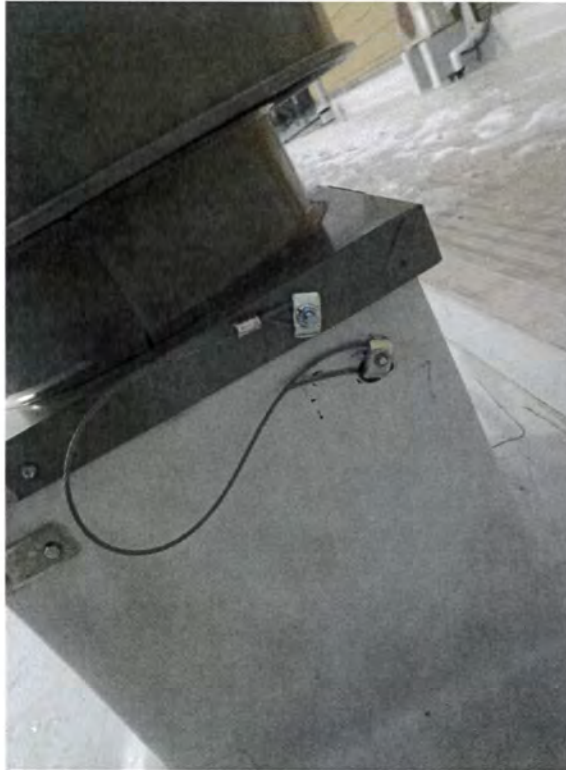
**Photograph 5**

- d. No gasket could be felt between the top of the curb and the hinged base of the vent. No repairs have been made. *On December 13, 2019, we were shown photographs of gaskets in the base of the vent at the curb.* See Photograph 5.

Vent at curb above Mechanical Room (Room 166) where gaskets have been installed

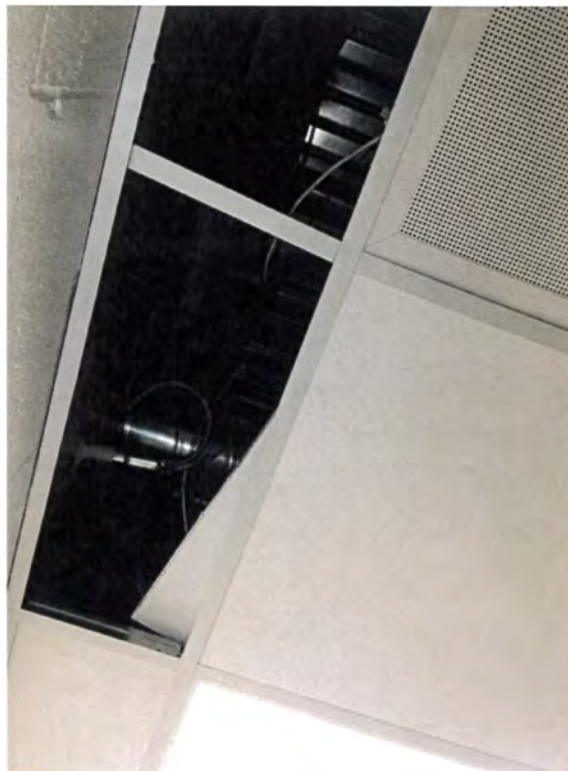
**Photograph 6**

*On December 13, 2019, ceiling tiles had been removed abutting the CMU wall where water leakage has occurred during recent rainstorms.*

Ceiling tiles removed in Kitchen Office 153

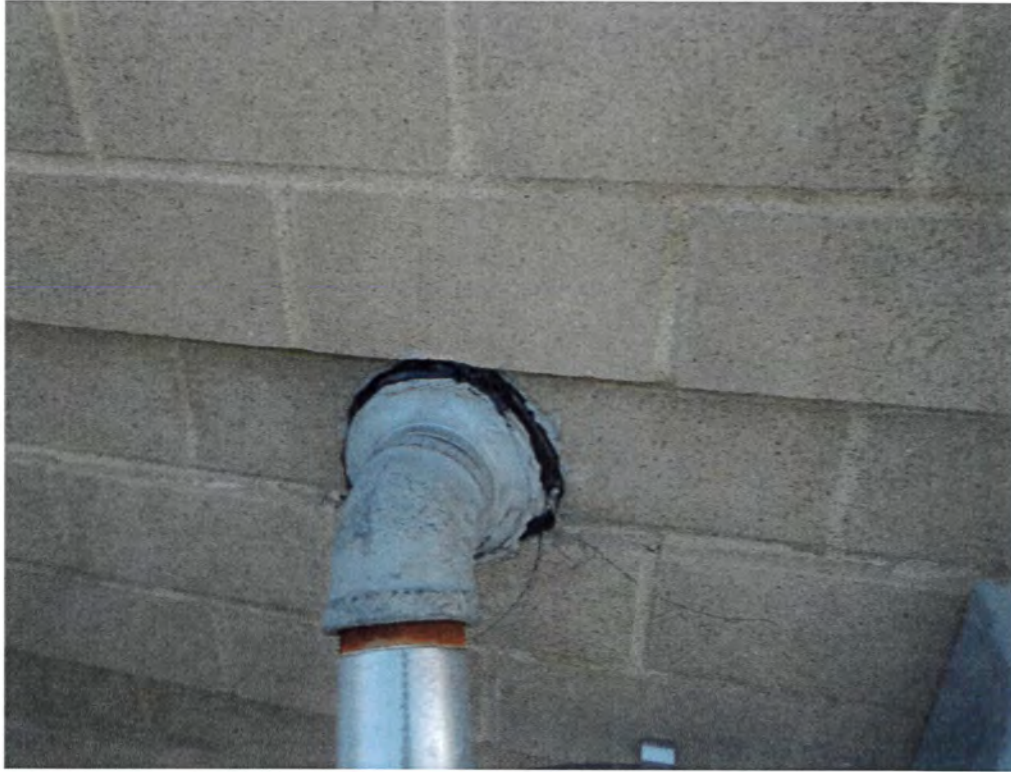
**Photograph 7**

1. Additional pourable sealant has been added to the top of the pourable sealer pocket. An uncured area of sealant was observed between the new and existing pourable sealant. The pourable sealant has cured.
2. Failed sealant was observed at the perimeter sealant of the vent pipe in the brick wall. *Sealant has been applied.* See Photograph 7.

Sealant applied at perimeter of vent pipe in brick wall at Kitchen Office 153

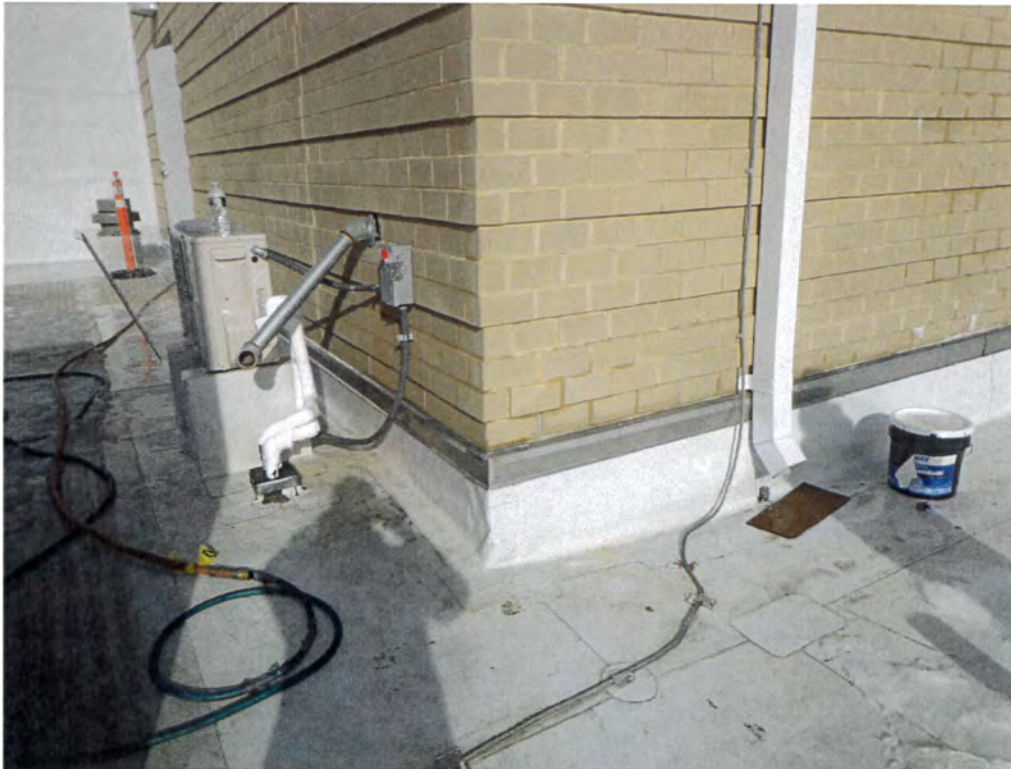
**Photograph 8**

*Test 1 Water was applied for 30 minutes a  $\frac{5}{8}$  inch diameter garden hose to the Sarnafil roofing membrane along the penthouse wall and around the pourable sealer pocket. No leakage was observed on the interior.*  
See Photograph 8.
