## PROJECT MINUTES

Project:	New Bourne Intermediate School	Project No.:	15041
Prepared by:	Joel Seeley	Meeting Date:	11/21/19
Re:	School Building Committee Meeting	Meeting No:	76
Location:	Veterans Memorial Community Center	Time:	6:30pm
Distribution:	School Building Committee Members, Attendees (MF)

Re: Evaluation of Water Leakage  
James F. Peebles Elementary School  
70 Trowbridge Road  
Bourne, Massachusetts

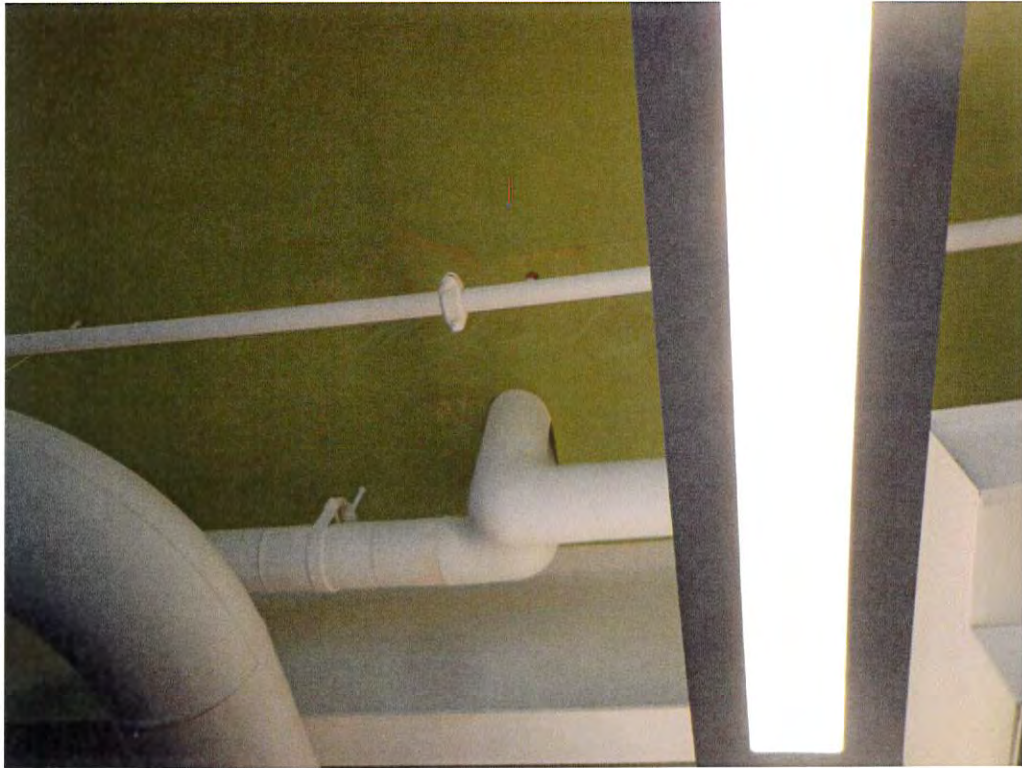
**Photograph 1**

1. Heavy water staining was observed on the ceiling around the roof drain on the green roof. See Photograph 1.
2. Small water stains were observed in spots on the ceiling on the north side of the classroom. See Photograph 2.

Water staining on ceiling of Art Room below drain on green roof

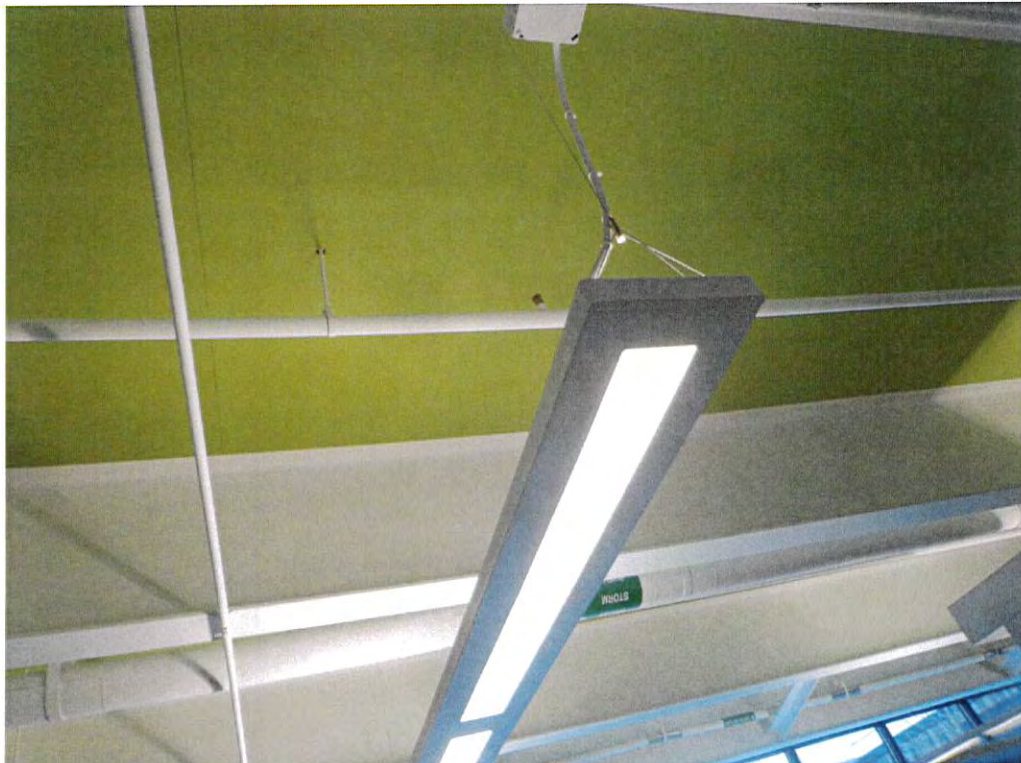
**Photograph 2**

Smaller water stains on ceiling on north side of Art Room

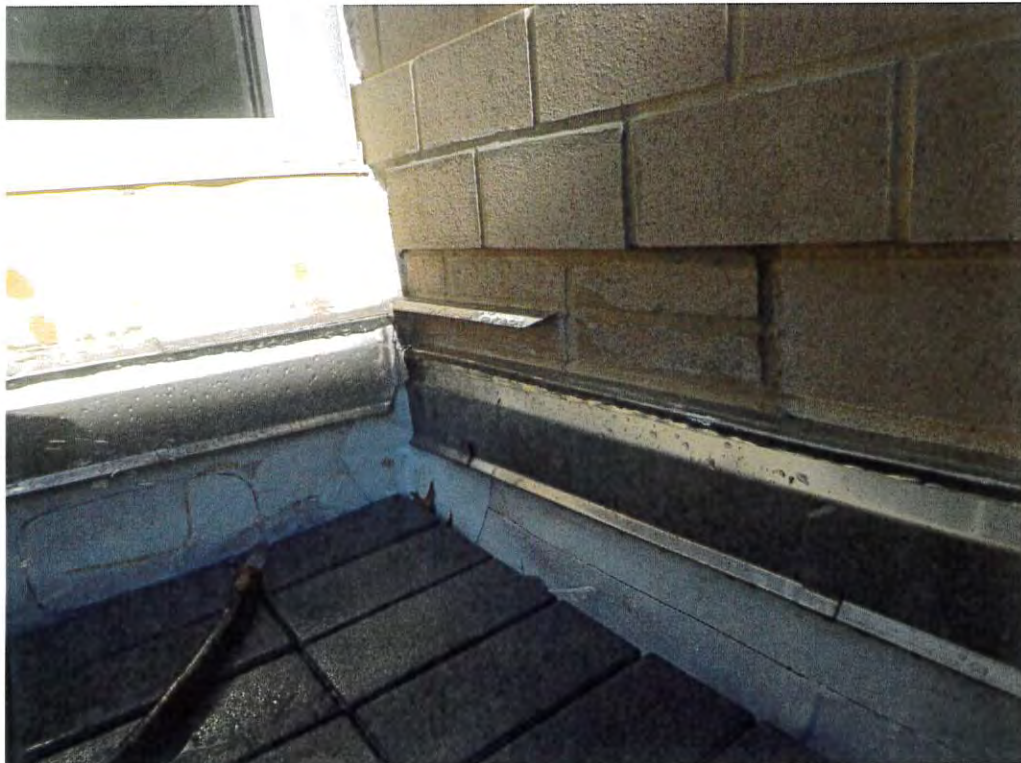
**Photograph 6**  
Stainless steel counterflashing outside Art Room

2. There is a step-up in the stainless steel counterflashing in the corners where the counterflashing beneath the cast stone units beneath the storefront window are located approximately 2 inches above the counterflashing in the brick walls. The counterflashing in the brick walls has a turned-up leg beneath the counterflashing beneath the cast stone return into the brick wall. See Photograph 6.

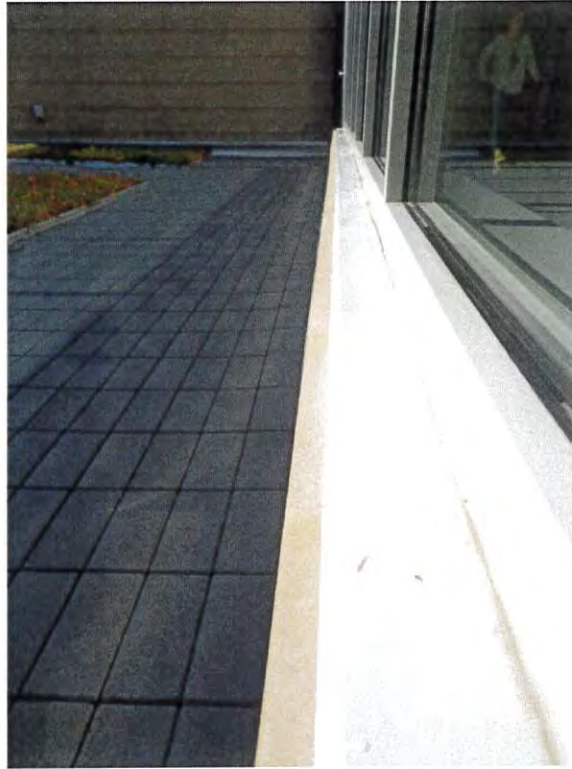
**Photograph 7**  
Sill flashing at storefront window in Art Room

Areas of failed sealant were observed in the joint between the sill flashing and the storefront sill.

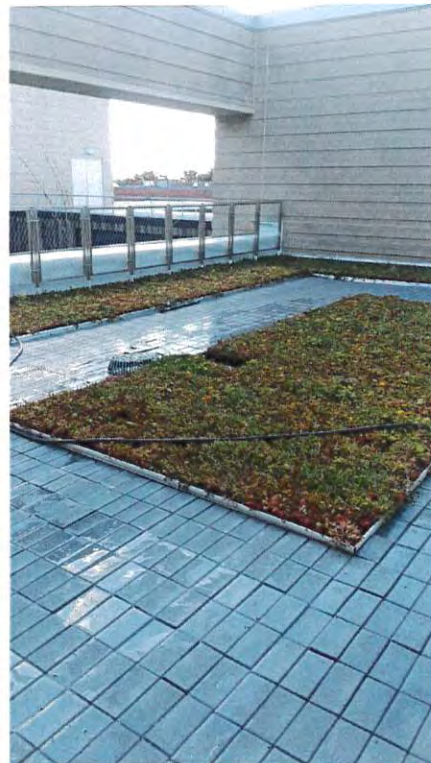
**Photograph 8**  
Flood testing of green roof

Approximately 30 minutes after allowing the water to drain from the roof, a wet spot was observed on the ceiling approximately 5 feet from the roof drain. See Photograph 8.

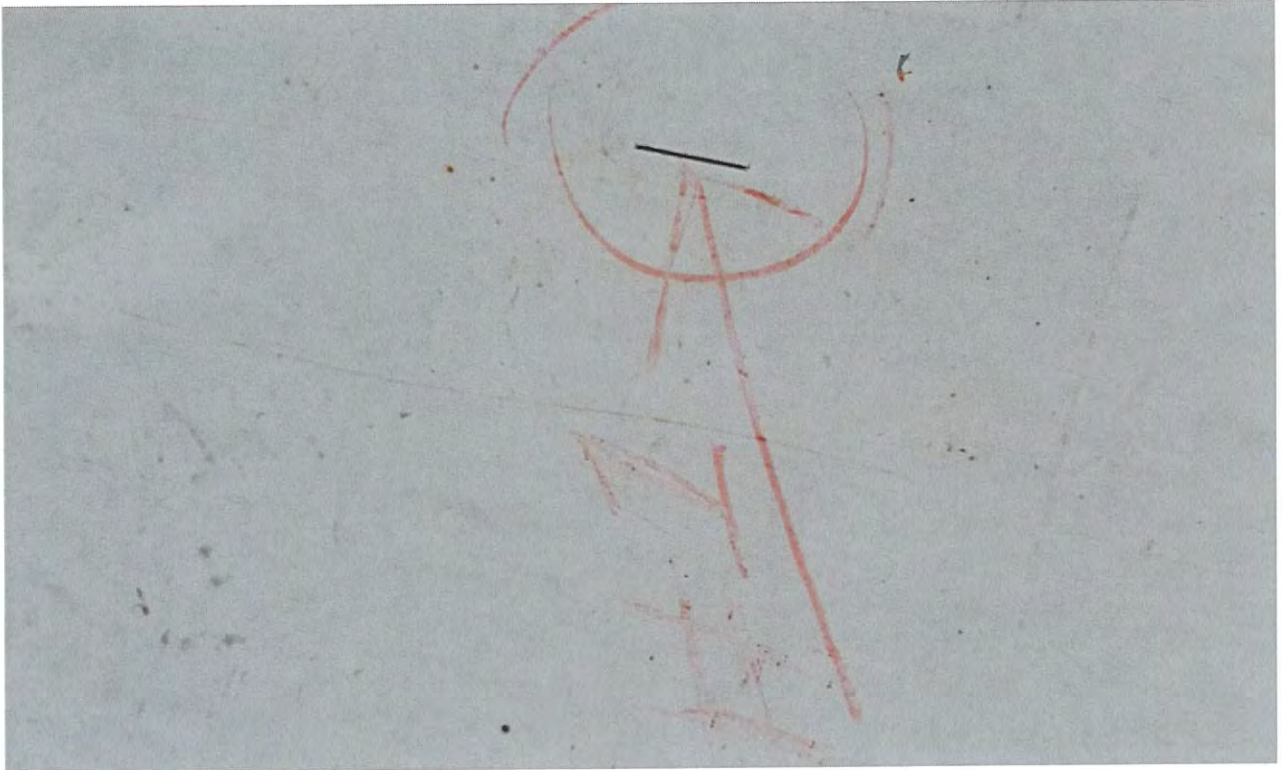
**Photograph 11**

Cut in roof outside of grid for vector mapping above second floor classroom

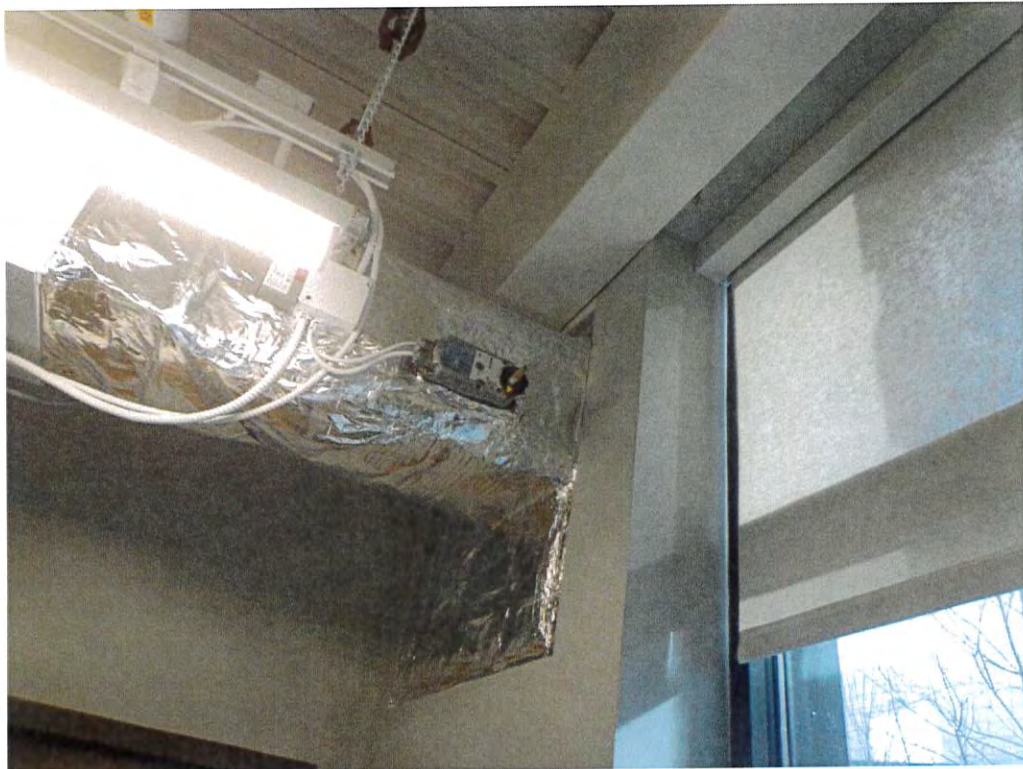
**Photograph 12**

1. Rust and water stains were observed on the underside of the second floor metal deck. See Photograph 12.
2. Water damaged Sheetrock was observed at the head of the window opening. See Photograph 13.
3. Blistered paint was observed on the wall by the door leading to the Art Room.

Rust and water stains on underside of second floor metal deck at Room 128

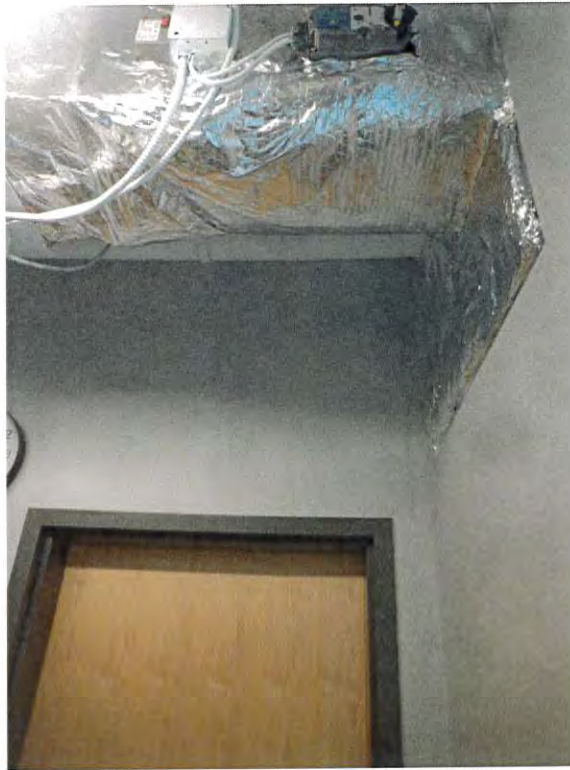
**Photograph 13**

Water-damaged Sheetrock at head of window opening in Room 128

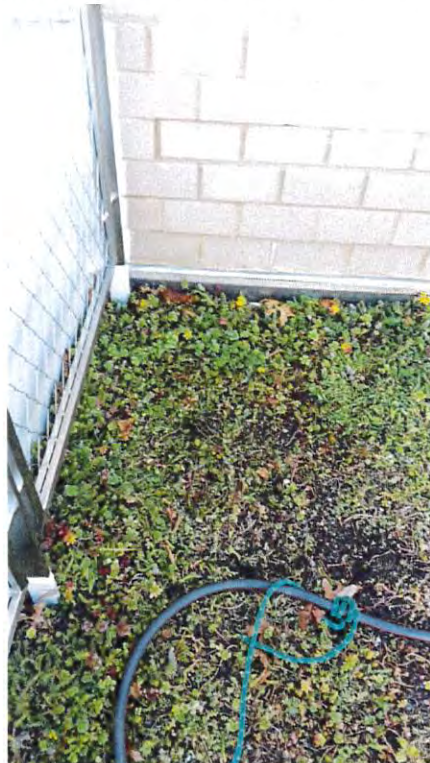
**Photograph 14**

1. The stainless steel counterflashing in the north-facing wall did not have a turned-up leg where it intersects the flanged flashing installed on the sides of the parapet wall. See Photographs 14 and 15.
2. The stainless steel counterflashing in the base of the suspended brick wall located above the parapet of the green roof is terminated at the face of the brick wall.

Stainless steel counterflashing in north-facing wall outside Room 128

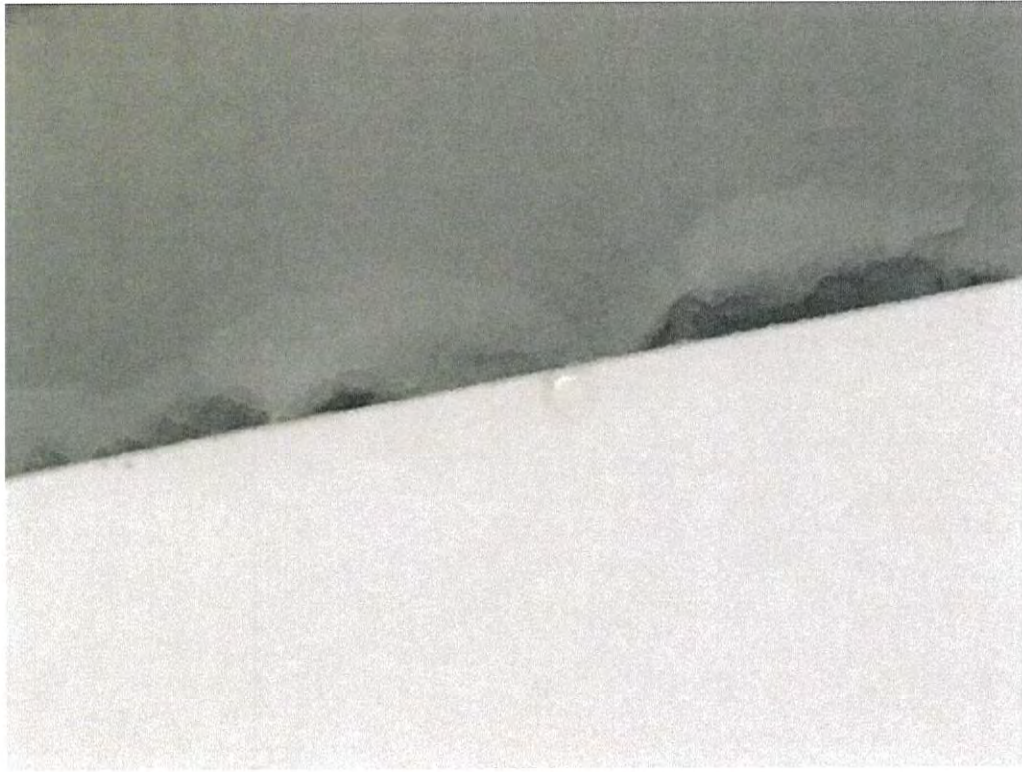
**Photograph 15**

Peeling paint and damaged Sheetrock at Main Entry vestibule

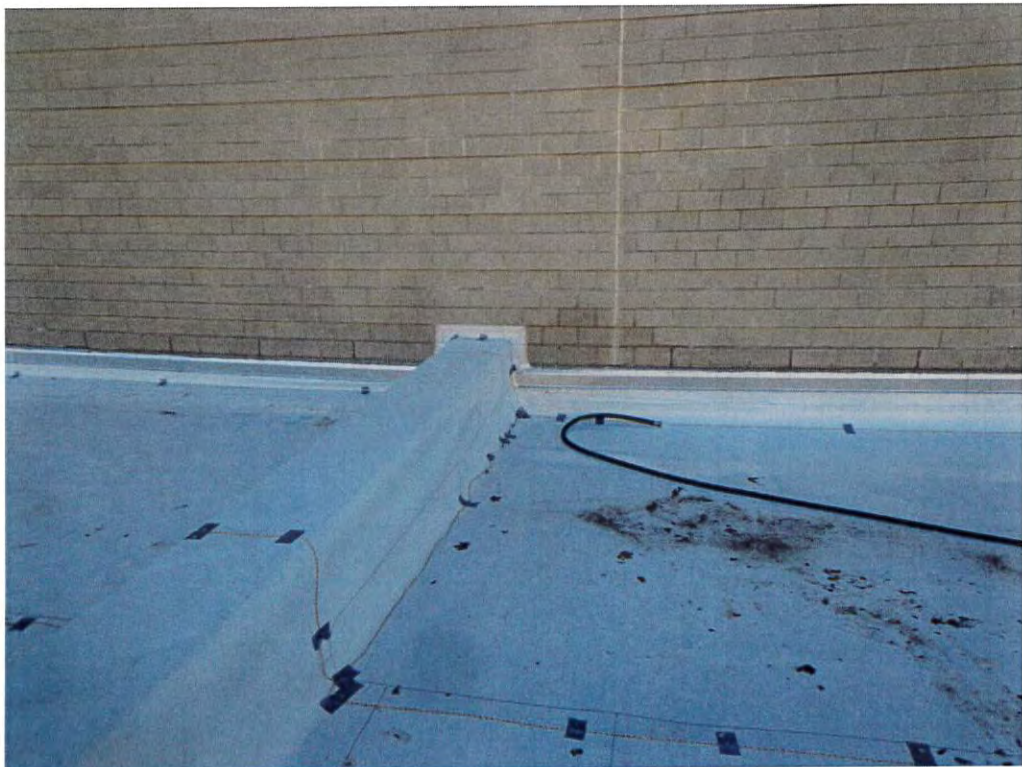
**Photograph 16**

Peeling paint and damaged Sheetrock tape were observed on the ceiling abutting the east wall. Stains were observed on the wall. See Photograph 16.

Encapsulated curb/wall above Main Entry vestibule

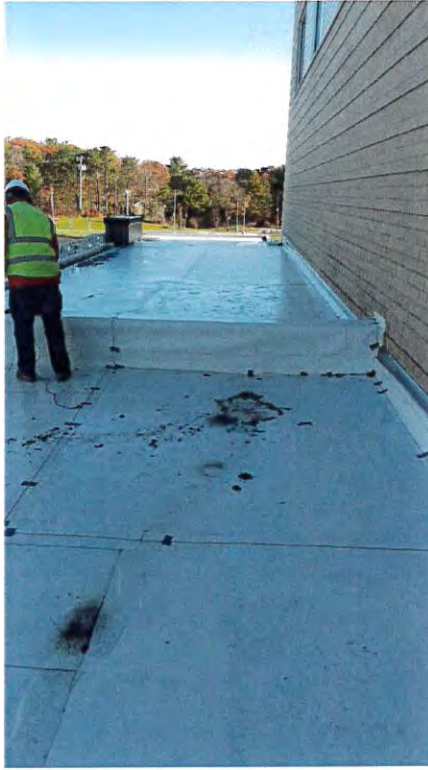
**Photograph 17**

Seams lacking seam patches above Main Entry vestibule

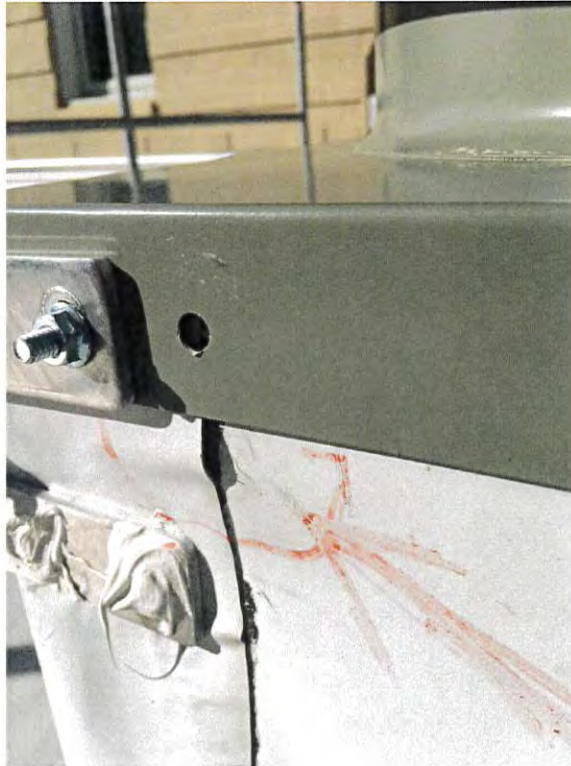
**Photograph 19**

Open seam in Sarnafil flashing on curb at Studio

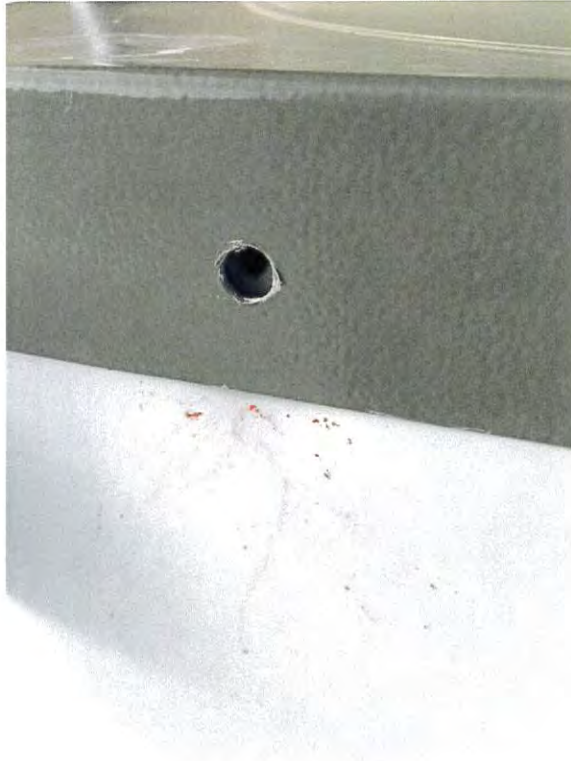
**Photograph 21**

Hole in Sarnafil membrane behind a screw port in vent hood base flashing at Studio

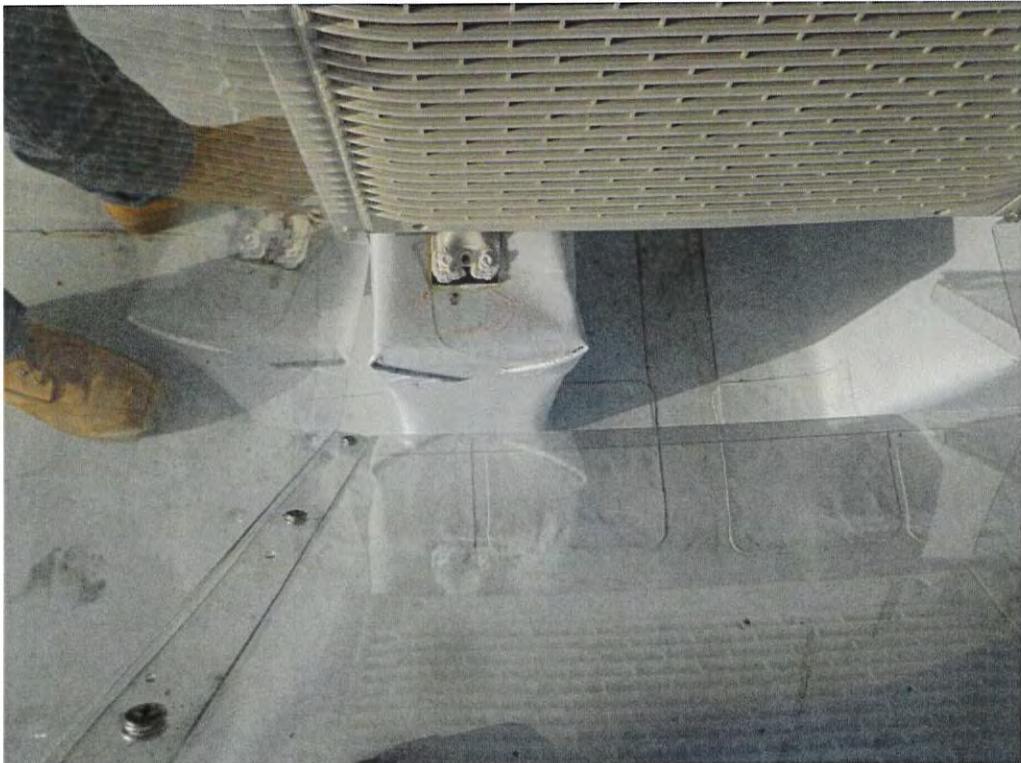
**Photograph 24**

We were informed that water leakage was observed at the ducts penetrating the roof deck. See Photograph 24.

Hole on top of a curb at Mechanical Room 166

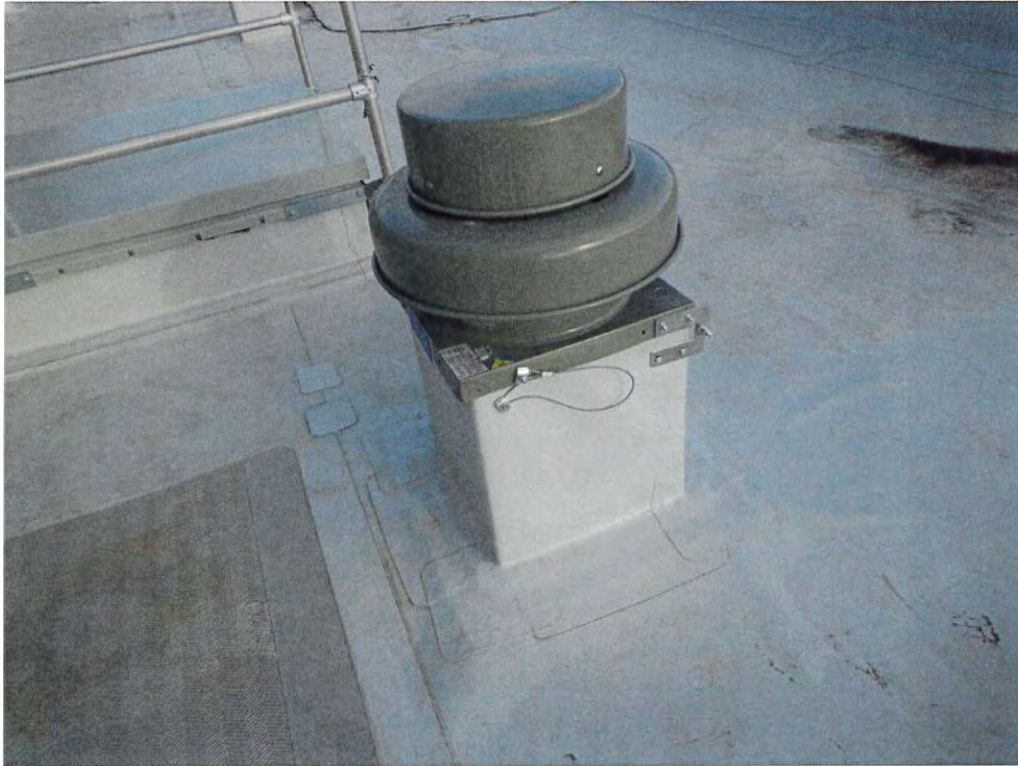
**Photograph 25**

Vent with hinged top at Mechanical Room 166

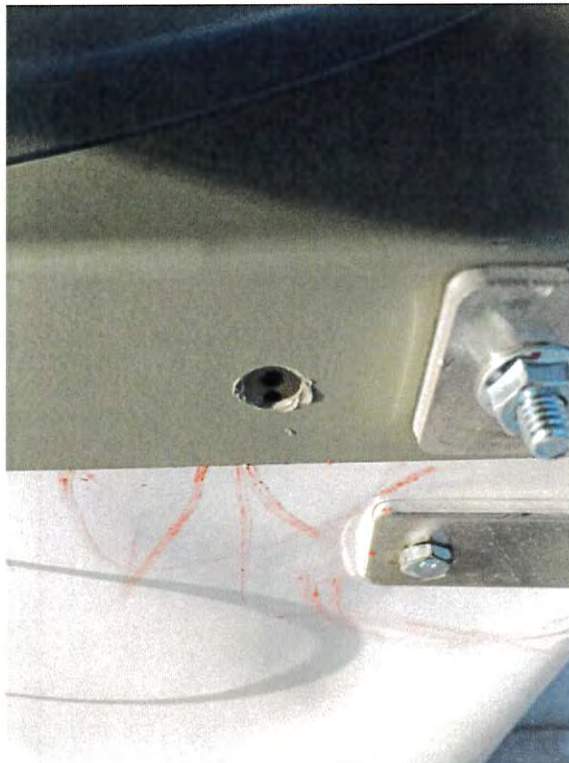
**Photograph 26**

Holes in Sarnafil membrane behind screw ports in Mech. Room vent hood base flashing

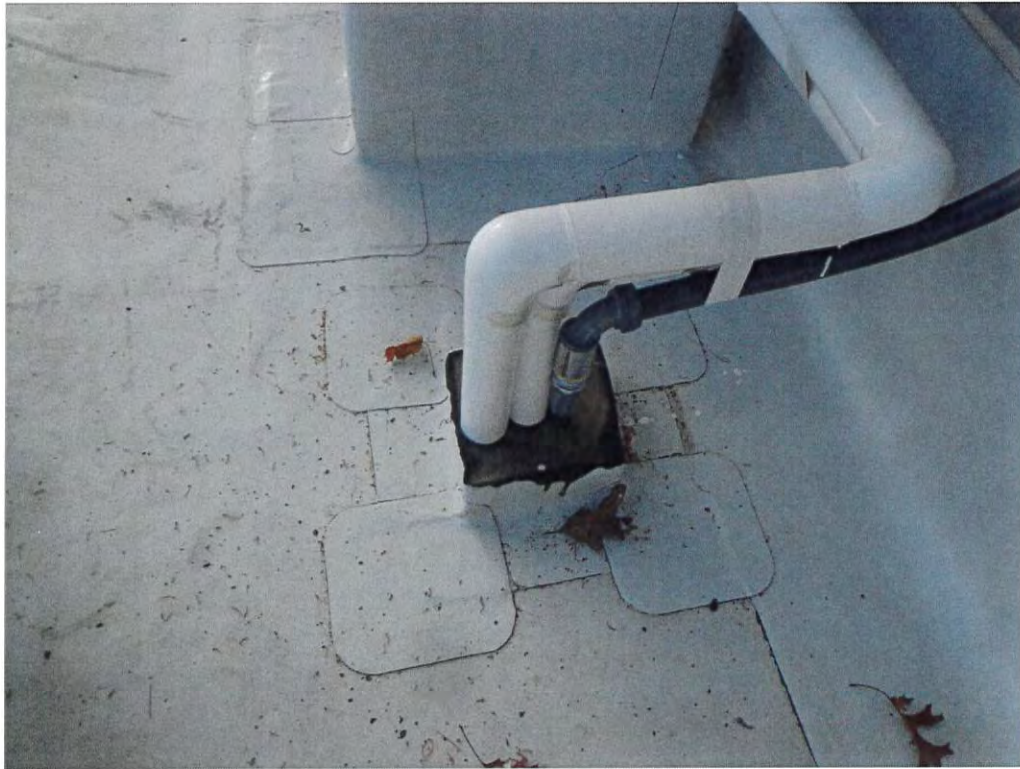
**Photograph 27**

Sealant below rim of pourable sealer pocket at Mechanical Room 166

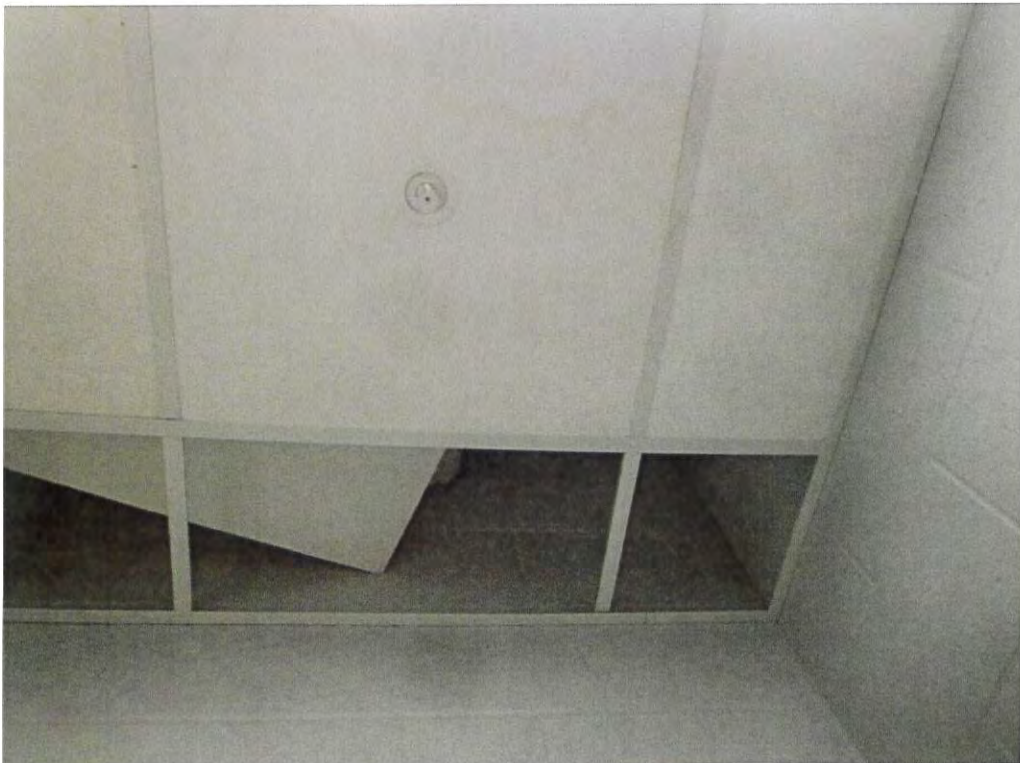
**Photograph 28**

Water stains on ceiling tiles in Bathroom Area near loading dock

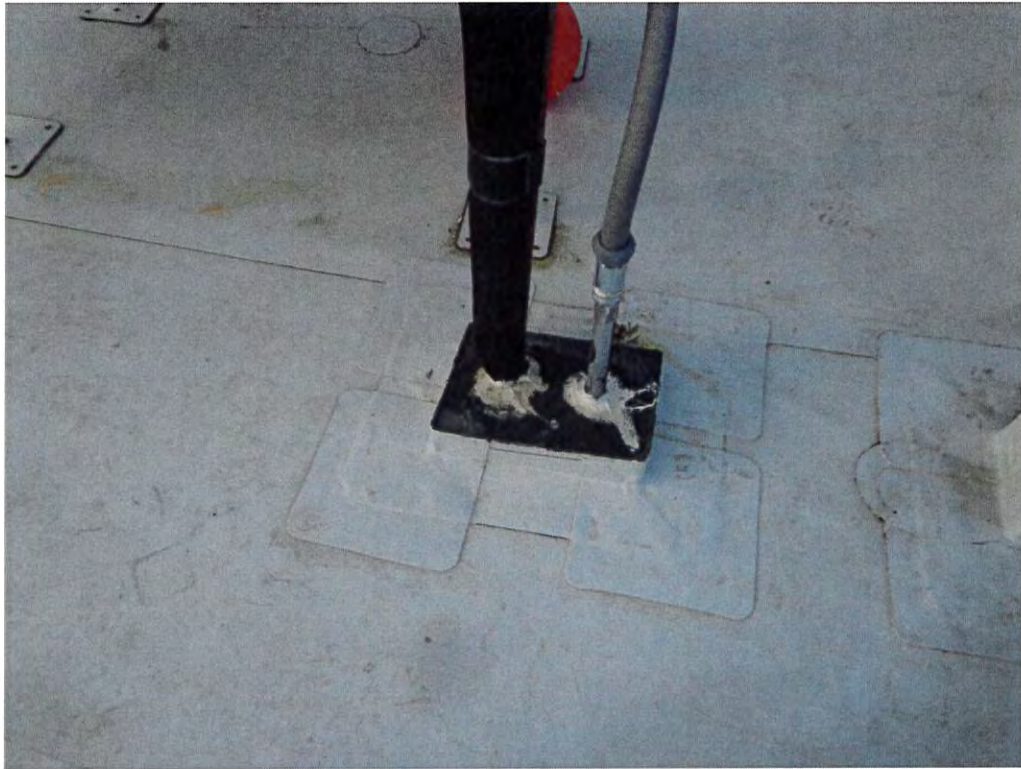
**Photograph 31**

Additional sealant at pipe penetrations above Bathroom Area

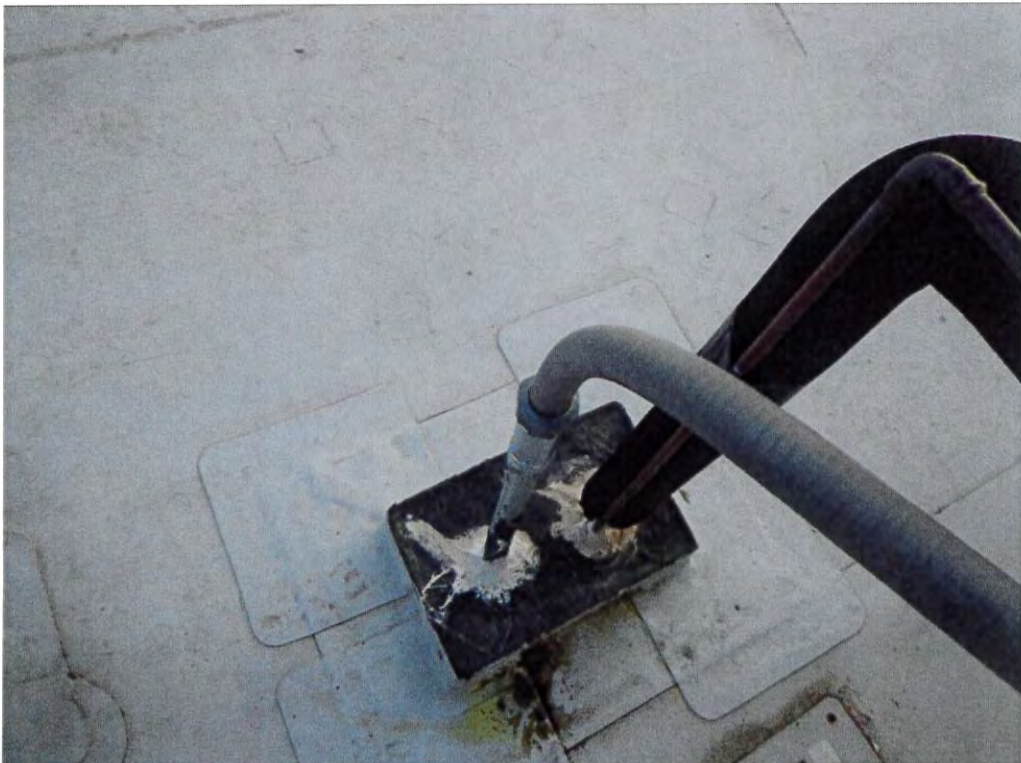
**Photograph 32**

Sealant recessed below rim of pourable sealer pocket above Bathroom Area

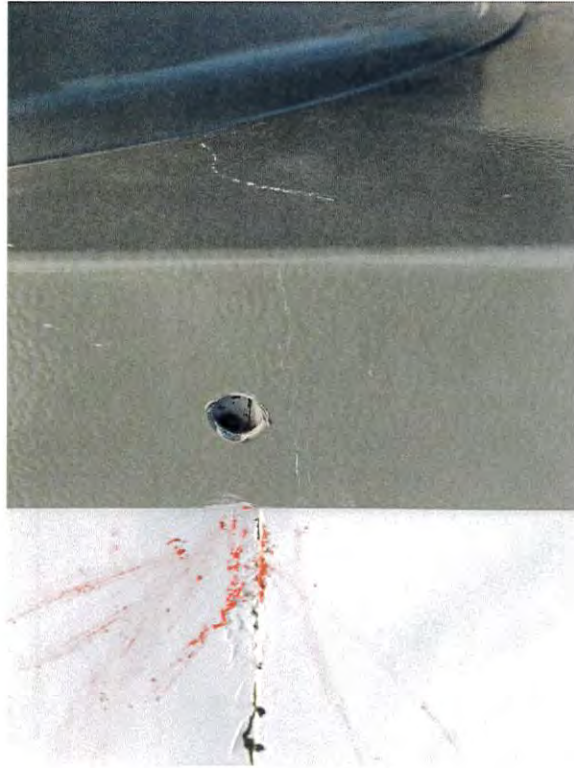
**Photograph 33**

Holes in Sarnafil membrane behind screw port in vent hood base flashing above Bathroom Area
