HOME INSPECTION REPORT

90 Adams St Sagamore, MA 02563

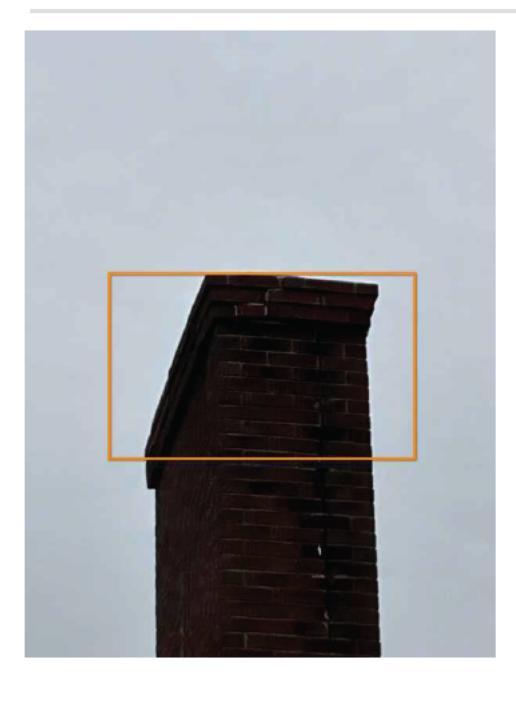
2.3.1 Chimneys

METAL RAIN HAT

Contact a qualified chimney contractor.

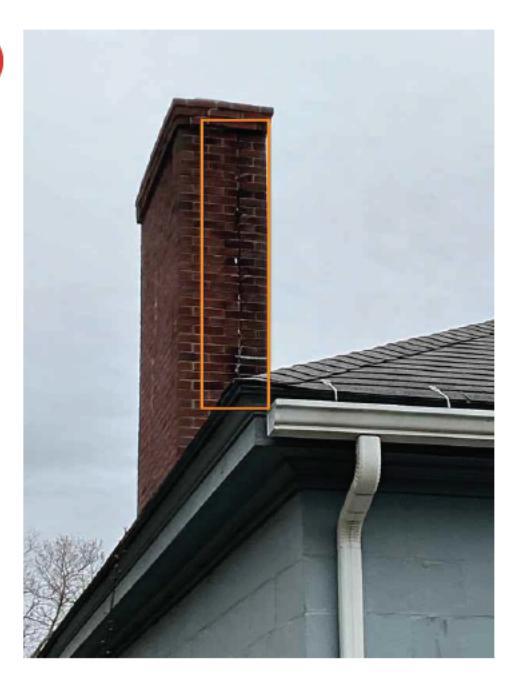
2.3.3 Chimneys

CRACKING IN BODY

Contact a qualified chimney contractor.

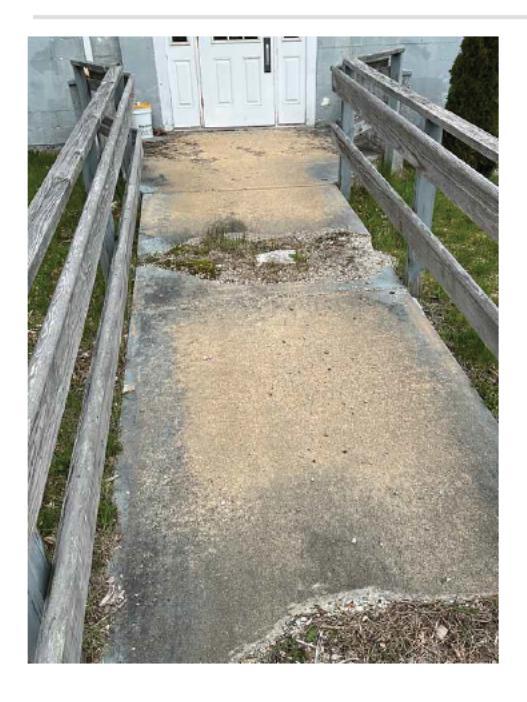
3.6.1 Driveways, Walkways and Patios **WALKWAY TRIP HAZARD**

The walkway is uneven. This may cause tripping or a fall. Recommend repairs as needed Recommendation Contact a qualified landscaping contractor

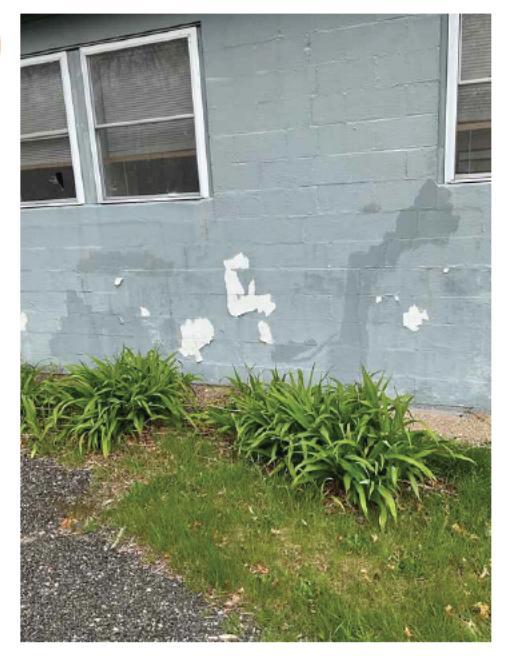
3.11.1 Wall Cladding

PAINT PEELING/CRACKED

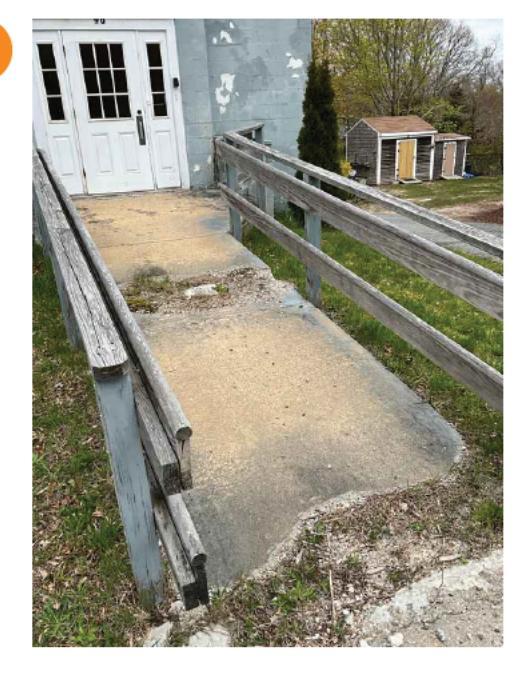
3.14.1 Stoops/Landings/Steps/Handrails

UNFINISHED

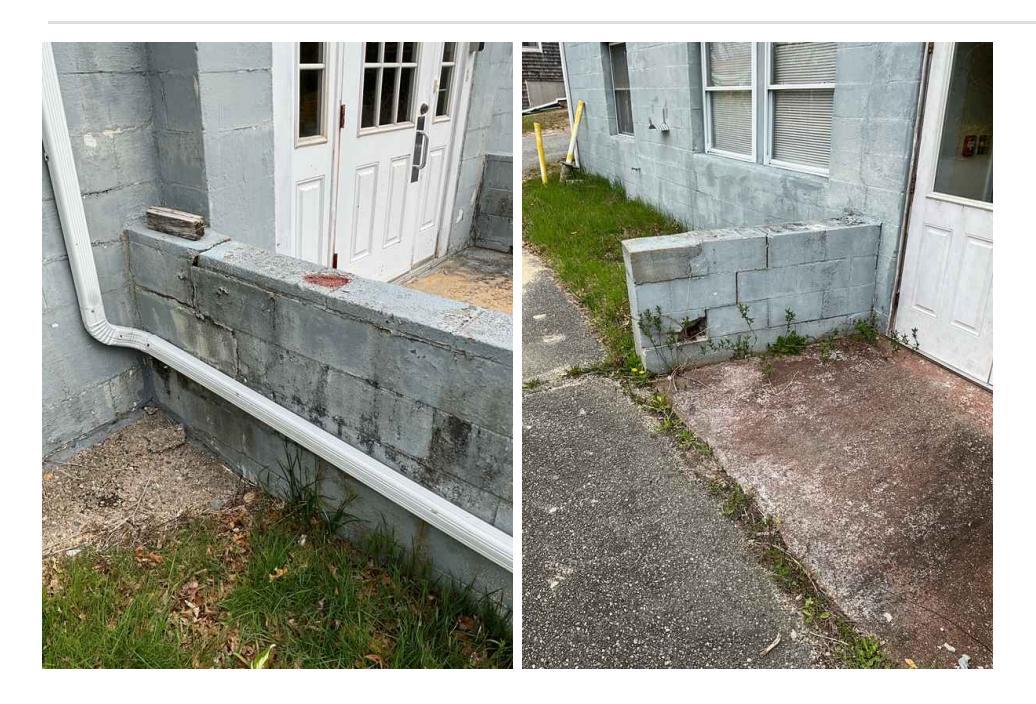
3.15.1 Guardrails **RETAINING WALL - POINTING/REPAIRS** FRONT AND REAR

Observed the masonry retaining wall needs pointing.

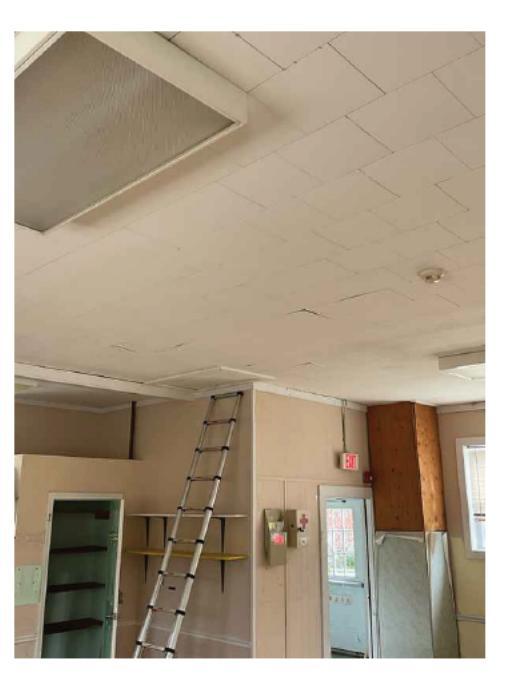
5.1.2 General

GENERAL RENEWAL

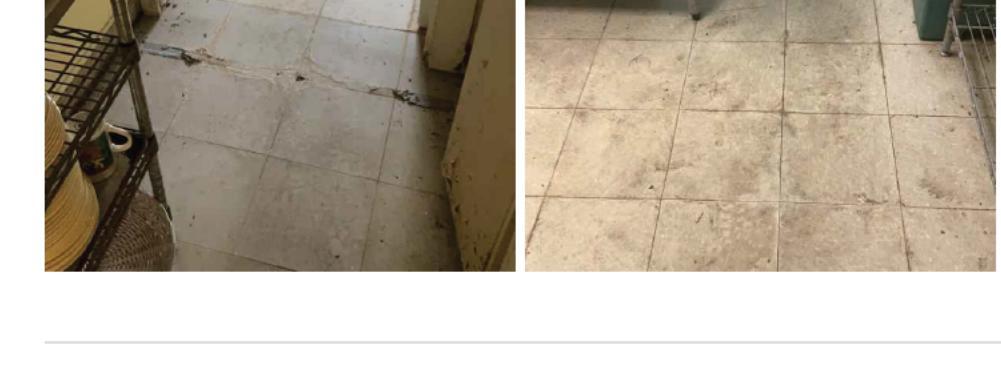
5.8.1 Floors DETERIORATED/RENEWAL

LOWER LEVEL

Contact a qualified flooring contractor

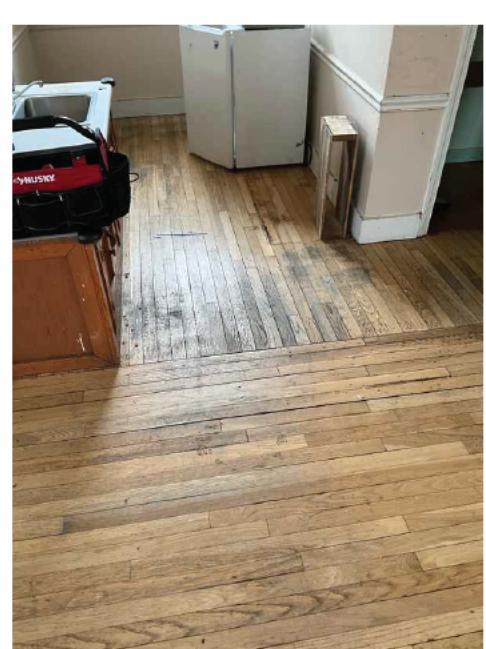
5.8.2 Floors

REFINISHING

Contact a qualified flooring contractor

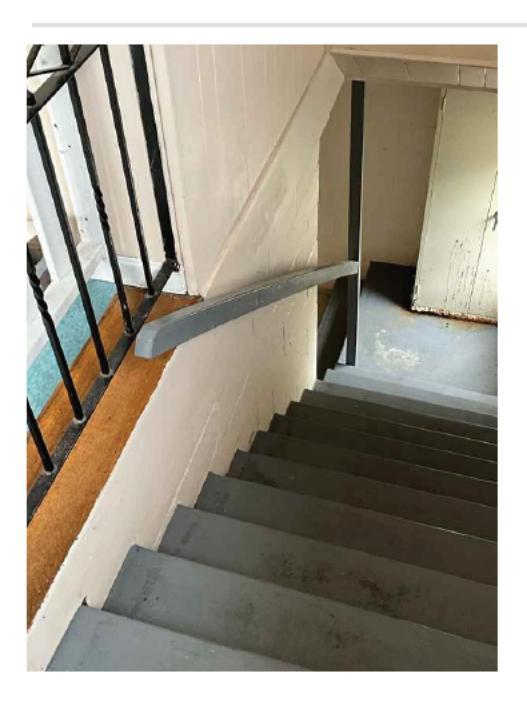
5.10.1 Stairways/Handrails HANDRAIL NOT GRIPPABLE

Handrails on stairway are not grippable. Recommend installing grippable handrails for safety.

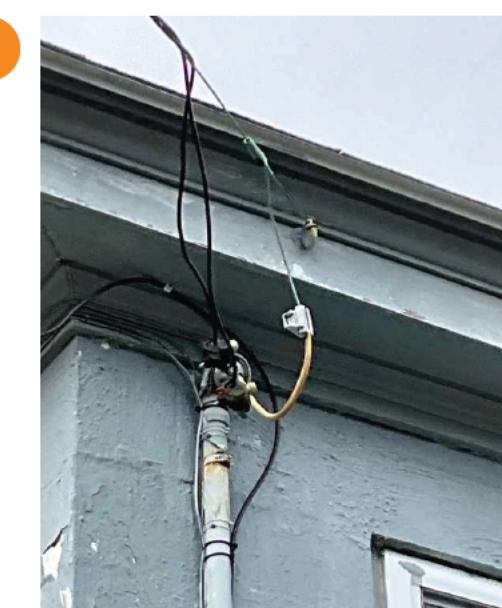
6.1.2 External

WEATHER HEAD DRIP LOOP INADEQUATE

Recommendation Contact a qualified electrical contractor.

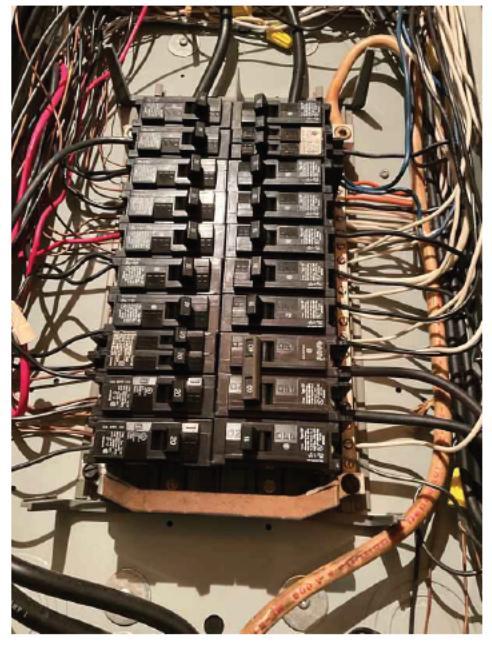
6.4.1 Main (Sub) Distribution Panel

NEUTRAL/GROUND SEPARATION

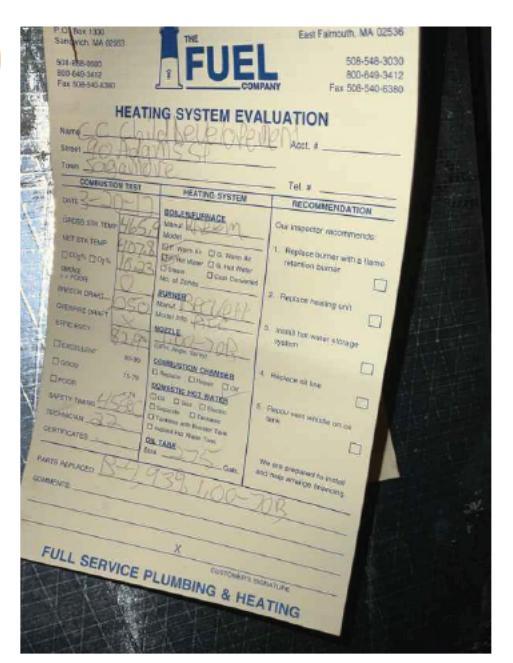
8.1.1 Overview NO SERVICE HISTORY

Recommend inquiring of seller of any documented servicing. If none, recommend having the burner and appliance serviced.

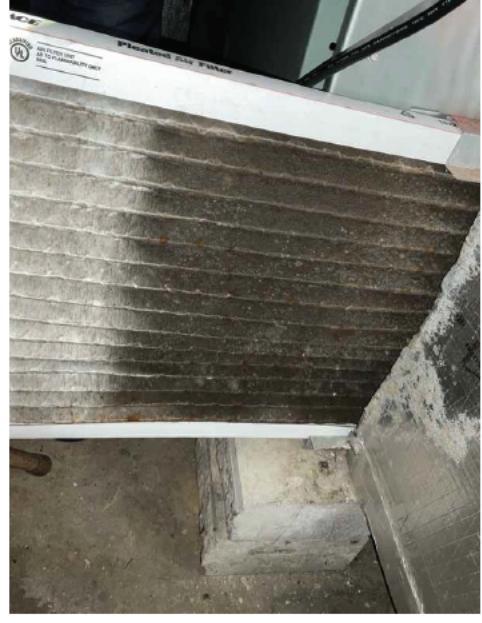
9.8.1 Filter

DIRTY

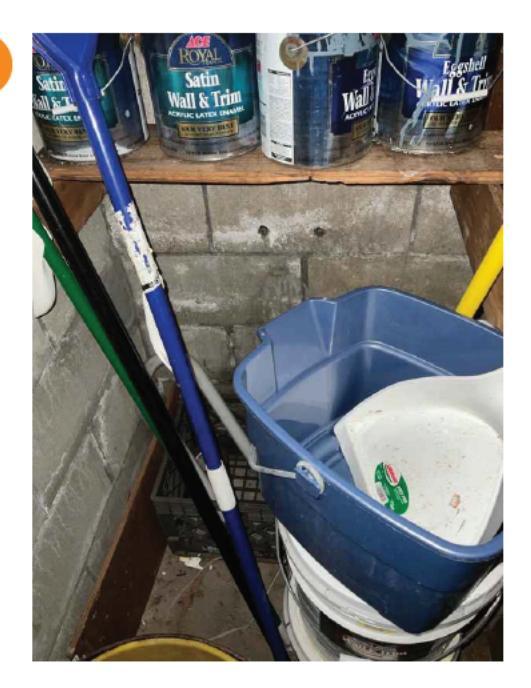
15.12.1 Moisture Penetration

HISTORIC LEAK EVIDENCE

Contact the seller for more info

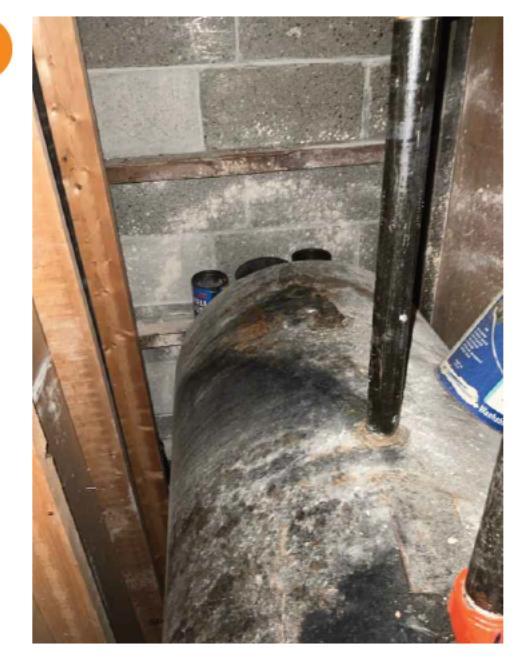
15.16.1 Basement Oil Tank

RUSTY
