Community Forum No.2
November 17, 2015
Feasibility Study

Bourne Elementary Schools Community Workshop

TOWN OF BOURNE, MASSACHUSETTS
PEEBLES ELEMENTARY SCHOOL
PROJECT SCHEDULE

EXISTING CONDITIONS UPDATE

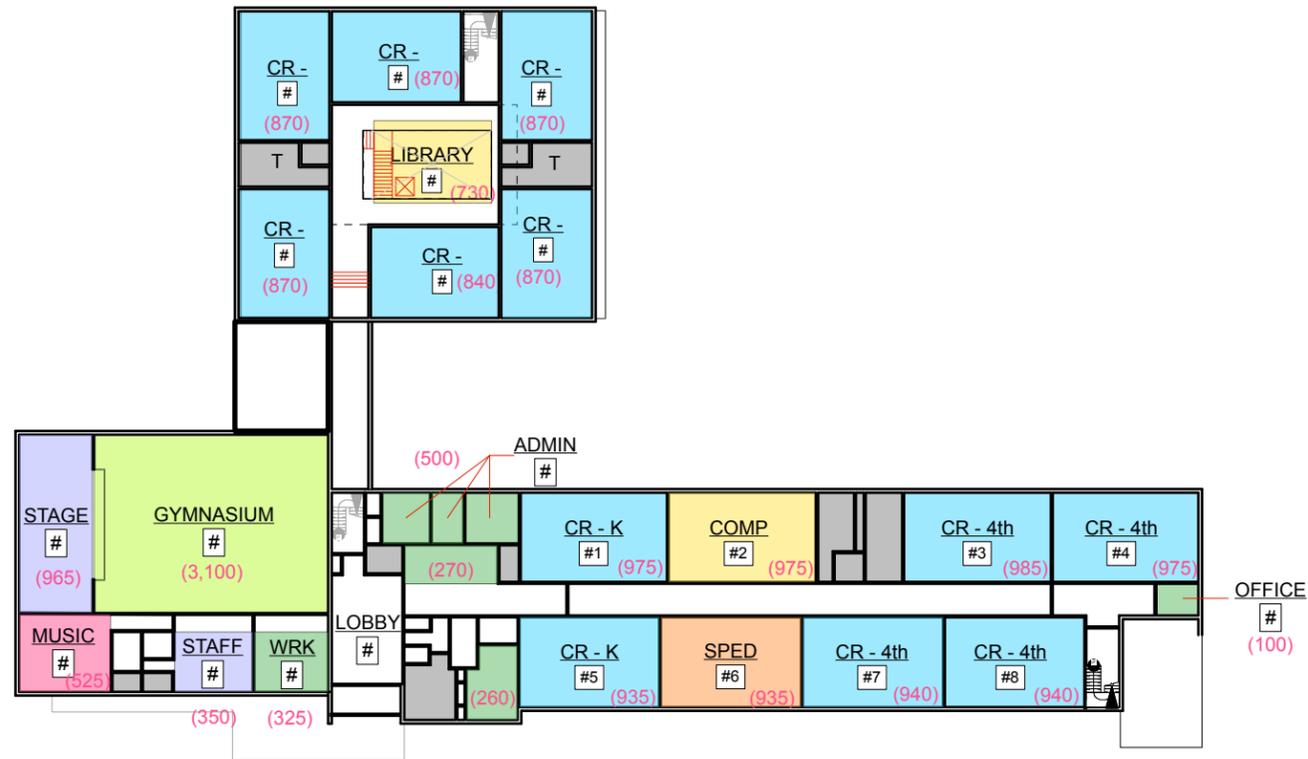
UPPER LEVEL PLAN

**PEEBLES ELEMENTARY SCHOOL
EXISTING FLOOR PLANS**

CORE ACADEMIC	20,300 SF
 SPECIAL EDUCATION	935 SF
 ART & MUSIC	1,325 SF
 PHYSICAL EDUCATION	3,100 SF
 MEDIA CENTER	730 SF
 COMPUTER	975 SF
 DINING	5,550 SF
 MEDICAL	260 SF
 ADMINISTRATION	1,195 SF
 CUSTODIAL	795 SF

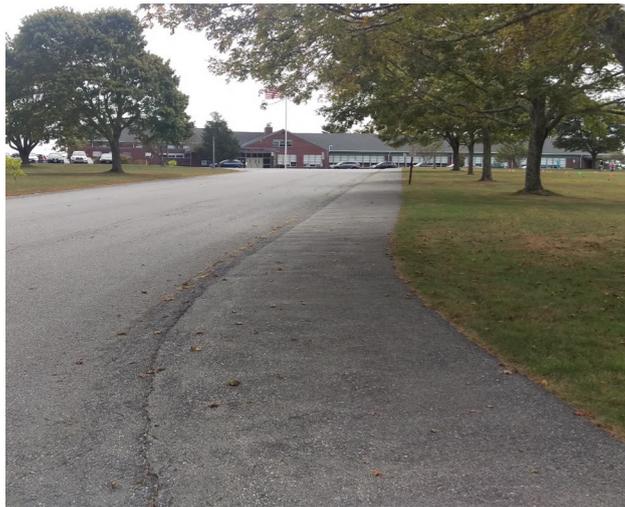
MAIN DRIVEWAY

- No compliant accessible route from Trowbridge Road to the main building
- Parent drop-off loop and area is inefficient and lacks proper student safety measures
- Safety zone for large playground structure does not meet fall zone height requirements
- Site drainage appears to be poor, with flooding at some entrance doors

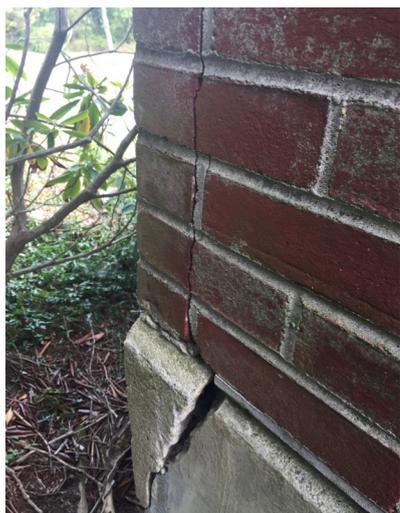
Exterior Masonry

- Exterior Envelope: Low R-value & masonry repairs required
- Roof System: Must be replaced with proper insulation added
- Window System: Single pane windows throughout, prone to water infiltration.
- Interior Walls: Repair and paint throughout and add acoustic treatment as needed
- Flooring: Replace all flooring throughout building. New epoxy floor system has been installed at cafeteria
- Ceilings: Replace ceiling throughout to accommodate new lighting and improve acoustics
- Door & Hardware: Systems are in various states of disrepair. Replace and provide for ADA access.
- Regulations: Upgrade as required to meet code

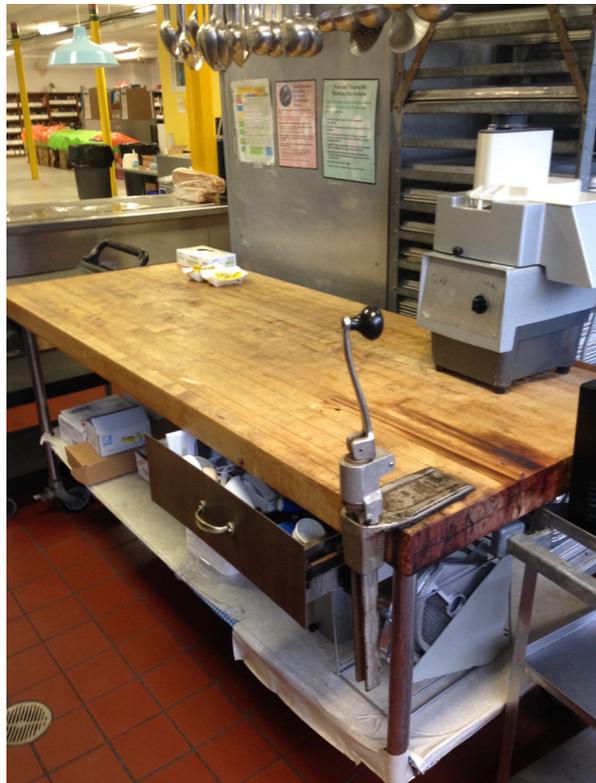
- Sink locations are not Handicap Accessible
- Student Chairs are many different manufacturers and various ages.
- Kitchen is old with outdated cooking equipment.
- Literacy library is in part of the cafeteria.
- Lack of storage space.

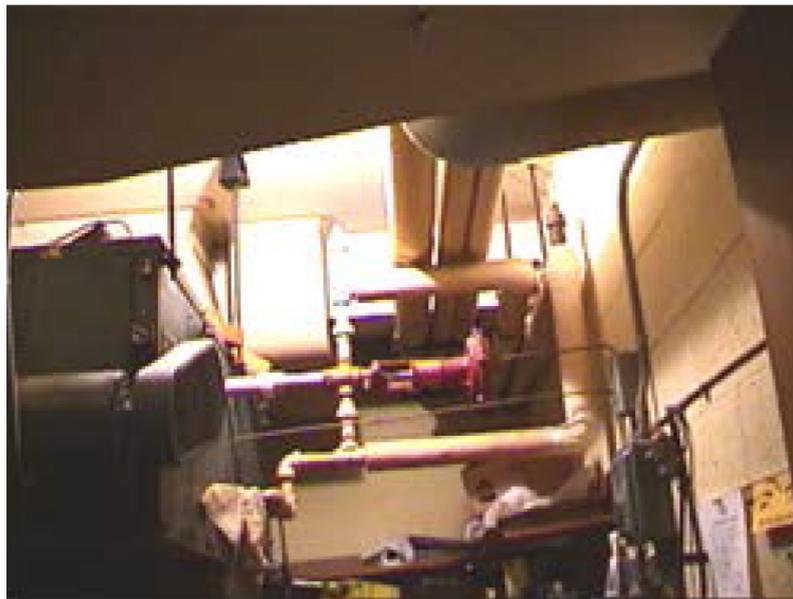
Air Handling Unit

- Antiquated mechanical system with poor efficiency
- Lack of controllability results in both under and overheated spaces
- Poor ventilation air
- Classroom unit ventilators are undersized and promote uneven and inconsistent distribution
- Air handling unit in the media center has exceeded its expected maximum service life
- Computer room lacks proper cooling

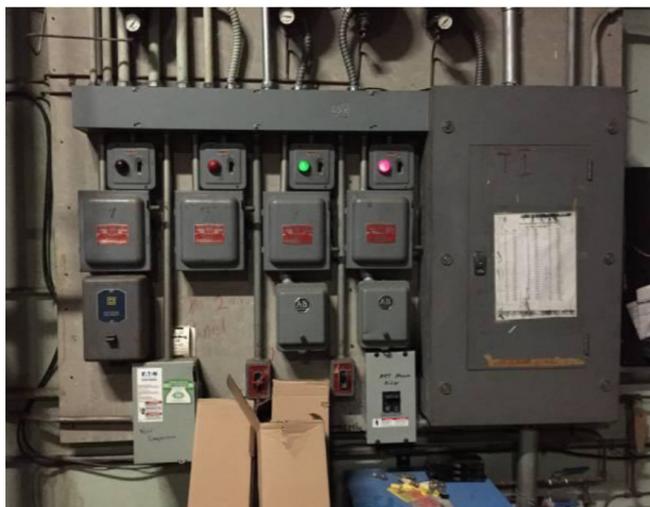
Distribution Panel

- The existing 600-amp main disconnect and fused distribution panel should be replaced
- Interior lighting throughout the school is in fair condition and should be replaced
- Existing exits signs should be replaced and additional signs provided
- A new generator or self-contained battery units should be provided
- All site lighting should be replaced
- Duplex outlets are sparsely located throughout with cords typically running across the floor
- Existing strobes do not meet ADA for intensity. Classrooms do not have ADA horn/strobe units
- A new fire alarm system will be required to meet code

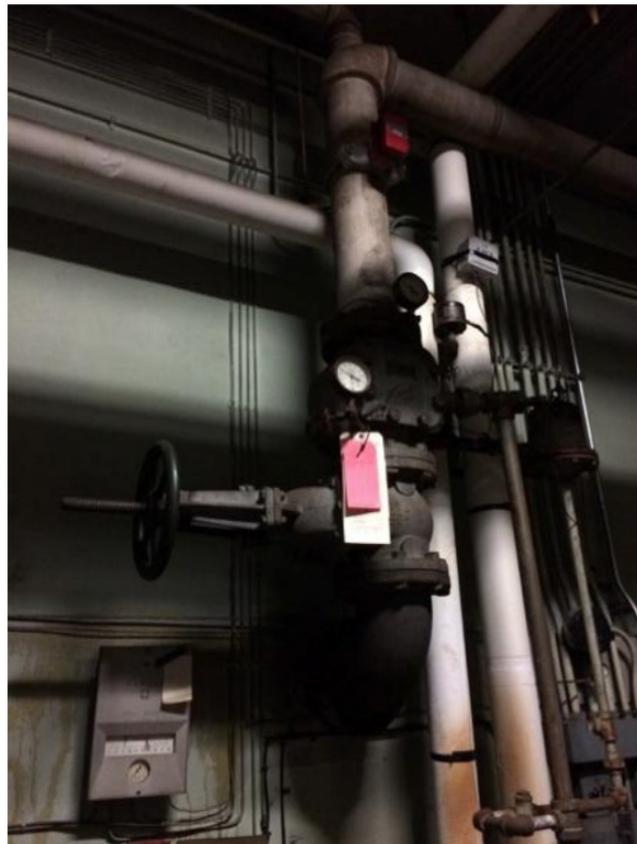
Fire Service & Alarm Valve

- Portions of the building are sprinklered
- The 1959 building is not sprinklered
- The service does not have a backflow prevention device
- The gate valve is not supervised by the fire alarm system

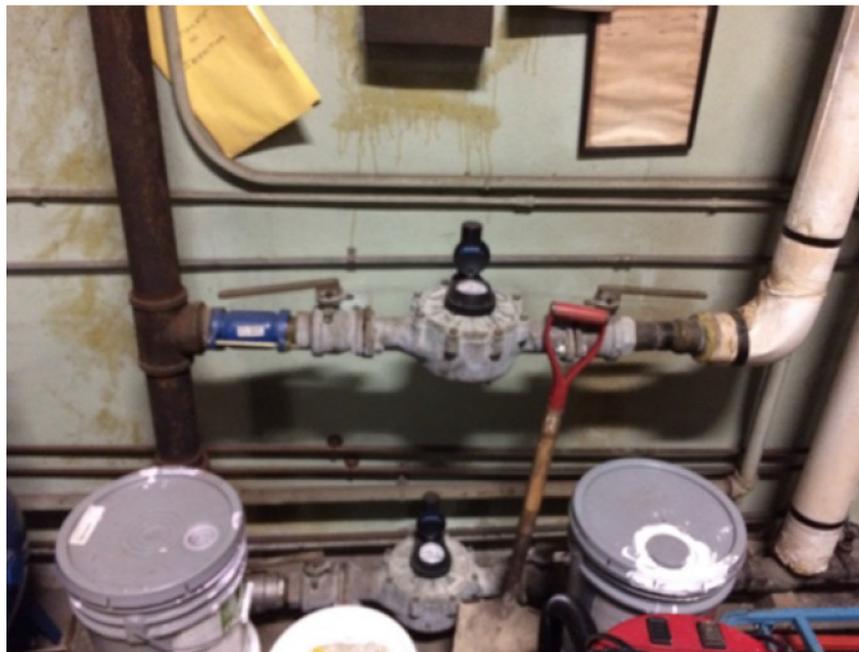
Domestic water meters

- A complete new piping system is recommended
- Plumbing fixtures are in fair condition
- Lack of back flow preventer on the domestic water system
- Wall hydrants on exterior are in poor condition
- Sanitary drainage piping is in fair condition
- The kitchen grease trap appears undersized for the load

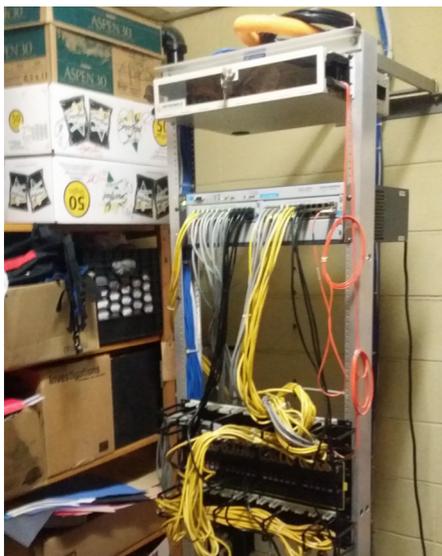
Tech Closet

- Technology Infrastructure: MDF and IDf in a share space in a storage room, No environmental control in equipment rooms, accessibility issues in spline Office area ceiling
- Communications System: Older wall speakers throughout, Older Simplex Master Clock System
- Telephone: Older Nortel System with handsets in classrooms and office
- Security: one CCTV camera at front door, some older motion sensors, Main door intercom
- Classroom Technology: SMART boards w/ ultrashort projection, HP desktop computers, Mobile Chromebook carts were observed (difficult to move around school due to lack of elevator)
- Network: Older and obsolete Procurve HP switch chassis in the closet, Some UPS equipment supporting network switches, 3-4 Enterasys wireless access points throughout
- AV Systems: Older speakers on stage area, No AV in Gym

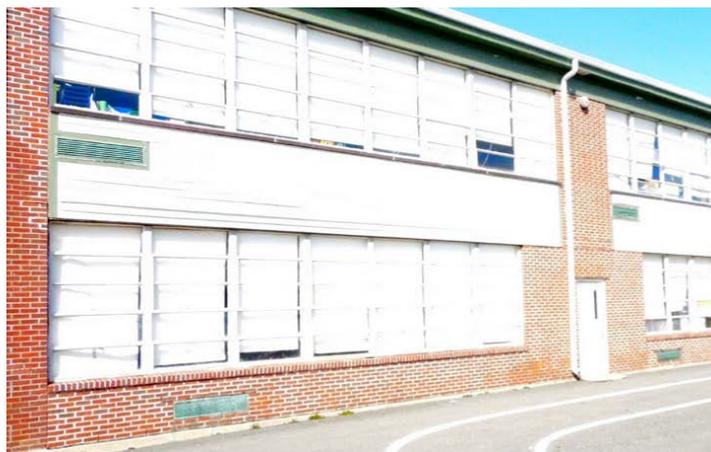
Vinyl Siding at Spandrel

- Masonry is exhibiting distress, bowing outward
- Water infiltration necessitated addition of vinyl siding at spandrel panels
- Corrosion in ungalvanized shelf angles and lintels is causing jacking of masonry
- Brick ties may have disintegrated due to corrosion - Masonry is pulling away from back-up wall
- Noticeable settling at ground floor of addition creates uneven condition at egress stair landings
- Addition was constructed over original septic leaching field, which may not have been well compacted during regrading and construction
- At addition, brick overhangs foundation 1 5/8" and is proud of concrete roof beam

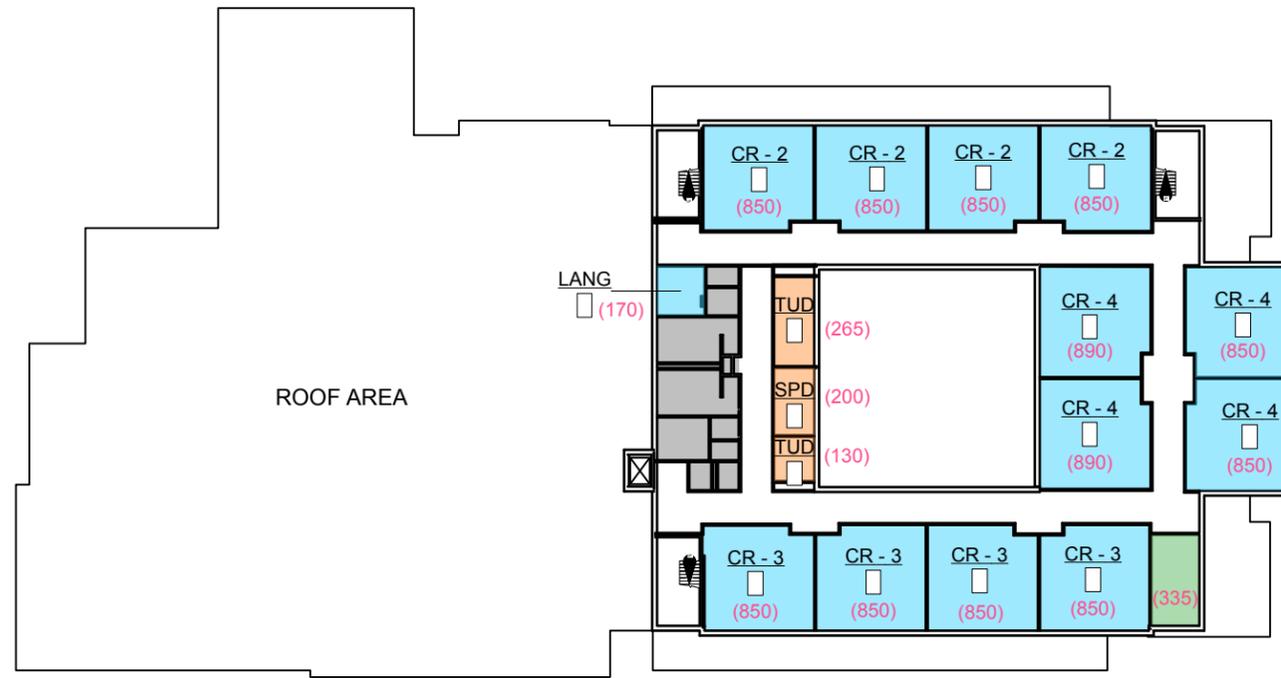
SECOND FLOOR PLAN

**BOURNEDALE ELEMENTARY SCHOOL
EXISTING FLOOR PLANS**

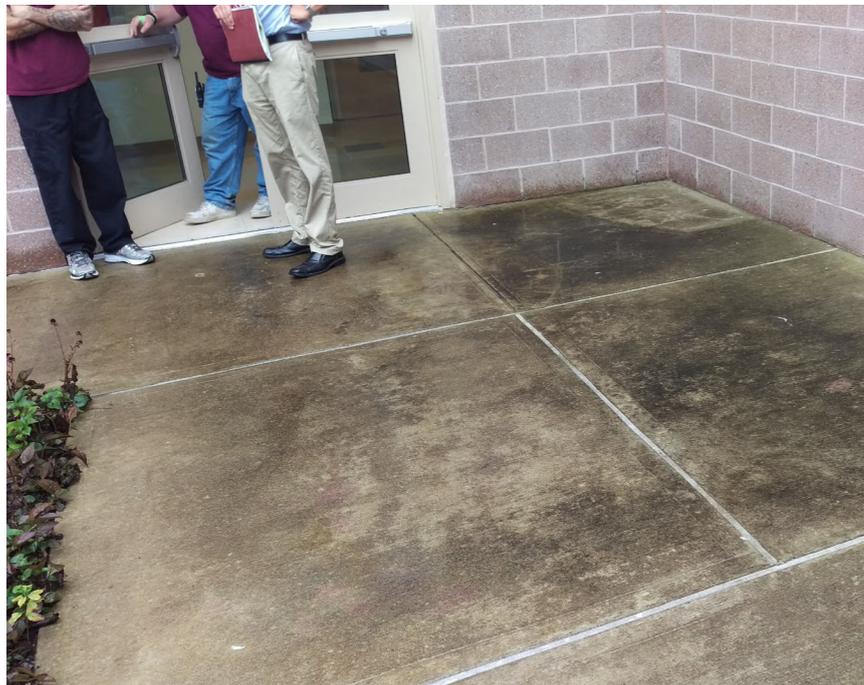
- Courtyard pavement does not drain properly and intermittently floods the adjacent hallway through the access door.
- No protective bollards at the flush sidewalk condition at the bus drop-off pick-up area at the rear of the school.
- Site drainage at the accessible spaces near the main entrance appears insufficient
- The school flagpole is not ADA accessible.

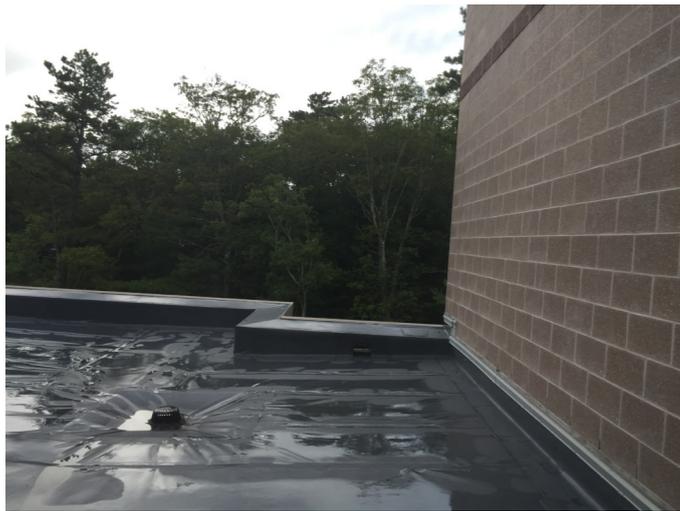
Roofing

- Exterior Envelope: Appears to meet code, analysis of components will be evaluated
- Roof System: Active leaks occur at “roof to wall” intersections, Flashing must be replaced, sealants require repair and replacement, Precast caps have open joints in areas
- Window System: Appears to meet code, analysis of glazing to be confirmed, precast sills require cleaning and sealing
- Interior: Proper acoustic separation required at nurse’s suite/music stage area. Additional corridor wall protection (i.e. wainscoting and corner guards)
- Flooring: VCT lifting up at doorways due to water infiltration
- Door & Hardware: Water enters at exterior sills. New sills and sloping concrete away from entry required. Gym doors require weather gaskets.

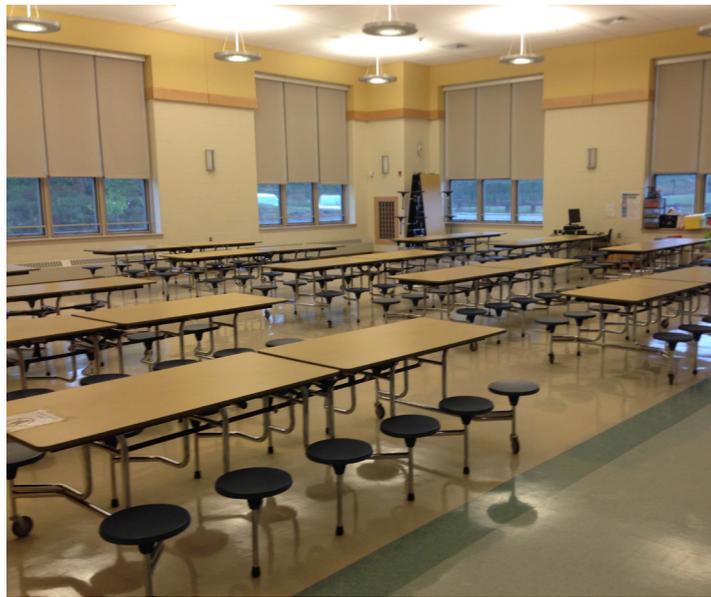
- Cafeteria is at capacity
- Lack of storage in kitchen
- Media center has no more space for books
- Classroom cubbies / furniture obstruct supervision and encroach on teaching area

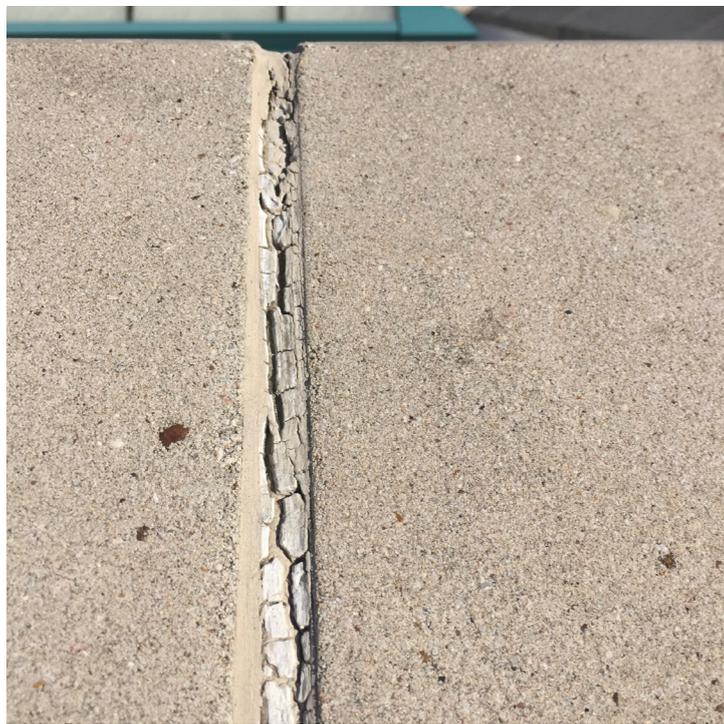
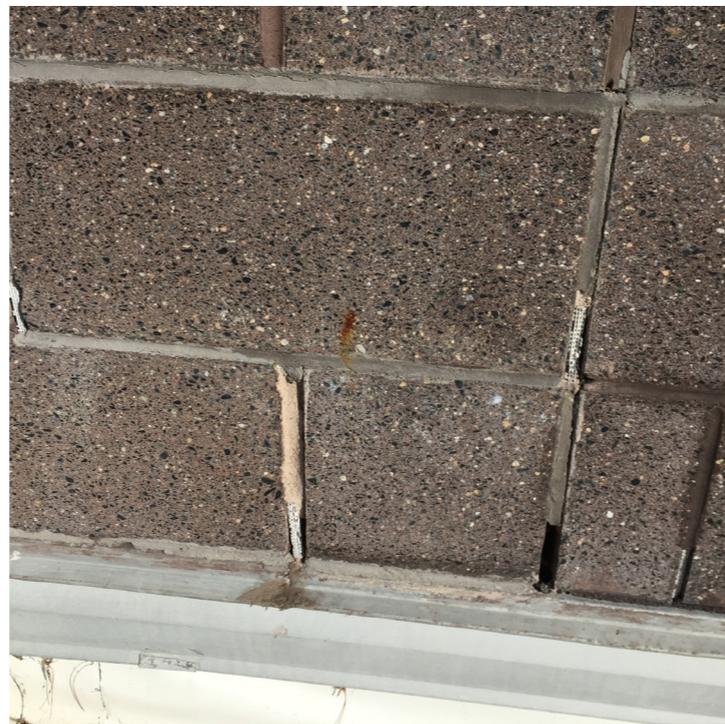
- Building is constructed of composite structural steel framing, open web steel joists, steel columns and masonry bearing walls. The building appears in good structural condition.
- In some locations, 8" architectural recessed units were mortared to adjacent units. Cracked mortar should be removed and replaced with sealant.
