HOME INSPECTION REPORT

90 Adams St Sagamore, MA 02563

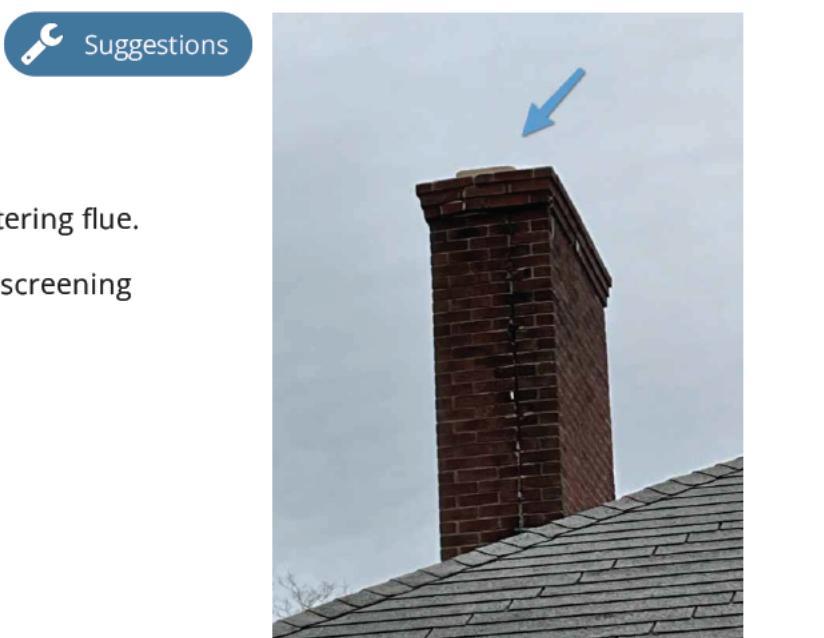
2.3.1 Chimneys

METAL RAIN HAT

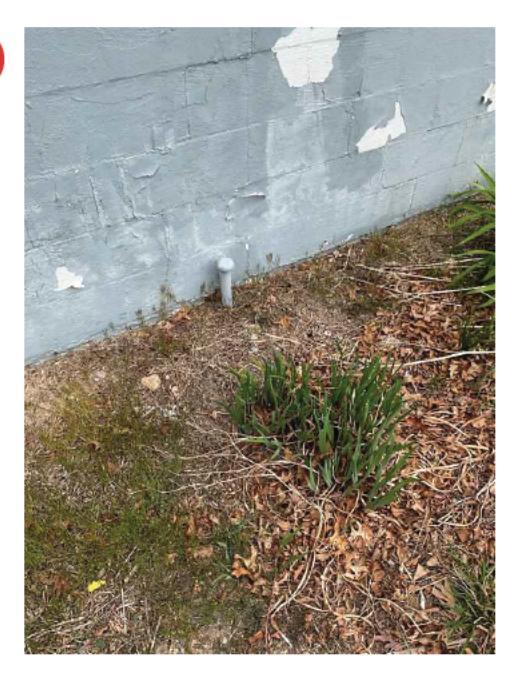
3.3.1 Exposed Foundation

Stair step cracking was observed on the exterior block foundation. While commonly found, and indicative of some degree of foundation movement, they should be examined further from the basement side to determine whether any remedial action is warranted. Often it is not.

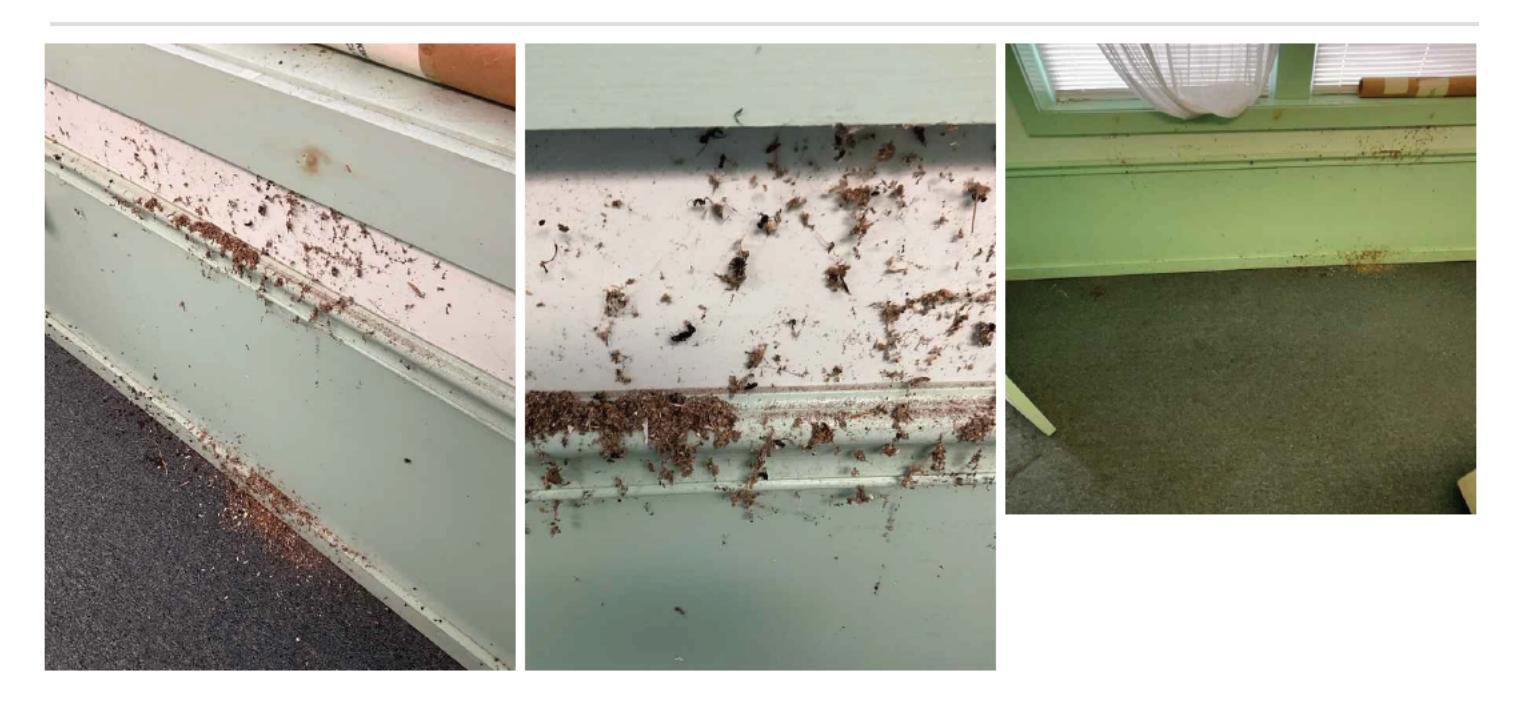
5.1.2 General

GENERAL RENEWAL

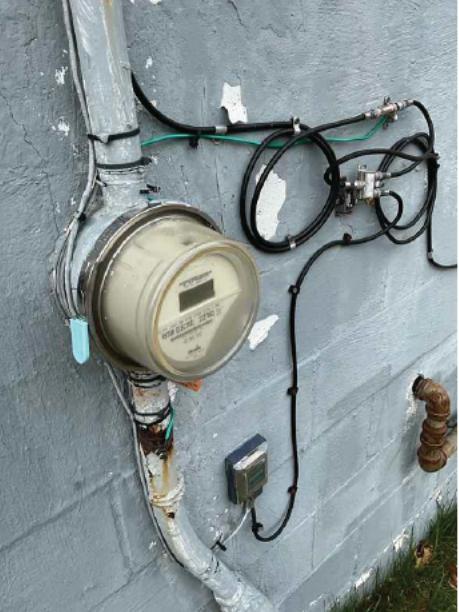
6.1.2 External

WEATHER HEAD DRIP LOOP INADEQUATE

Contact a qualified electrical contractor.

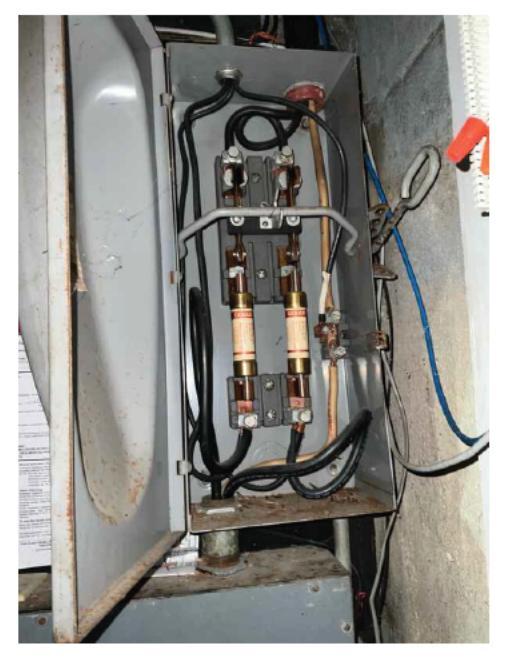
6.3.1 Grounding/Bonding JUMP ACROSS WATER METER

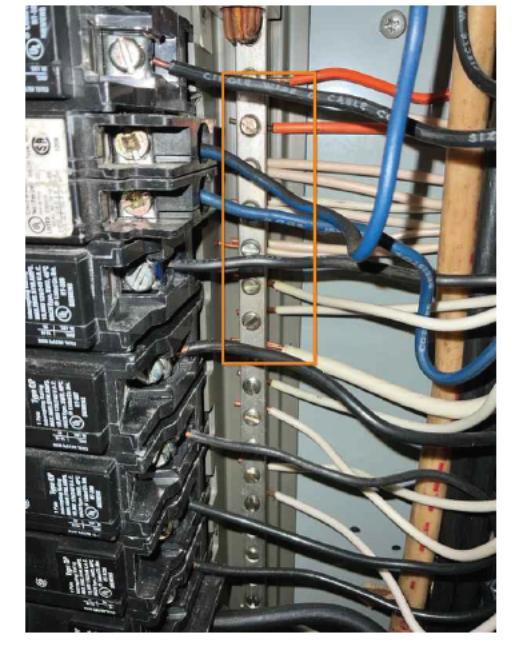
OVERWIRED

The distribution panel is overly filled with wiring in the inspector's opinion.
